# FINAL INVESTIGATION REPORT

## CHEVRON RICHMOND REFINERY PIPE RUPTURE AND FIRE

### CHEVRON RICHMOND REFINERY #4 CRUDE UNIT RICHMOND, CALIFORNIA

AUGUST 6, 2012

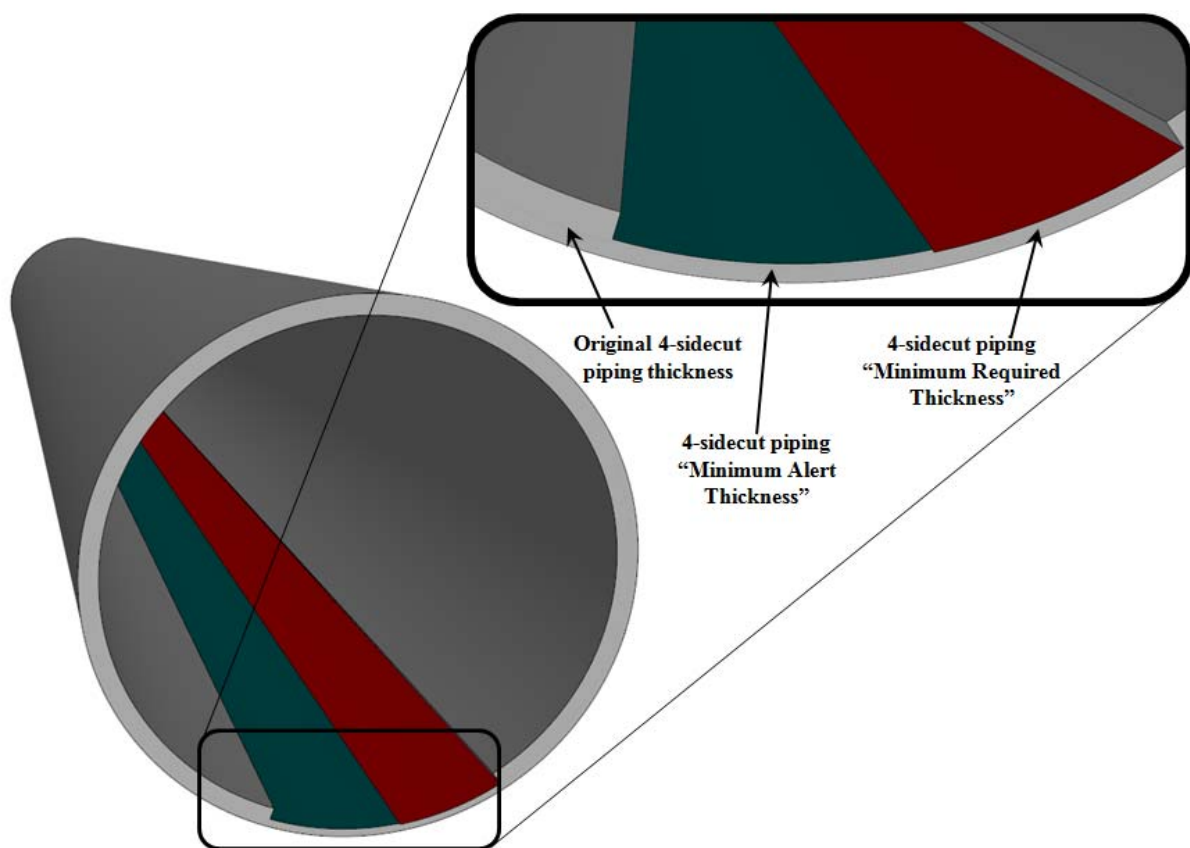
**Figure 1. To-scale schematic of 4-sidecut piping identifying key wall thickness values. These include the original wall thickness (0.322-inch), "Minimum Alert Thickness" (0.13-inch), and "Minimum Required Thickness" (0.11-inch) using API RP 574 default values.**

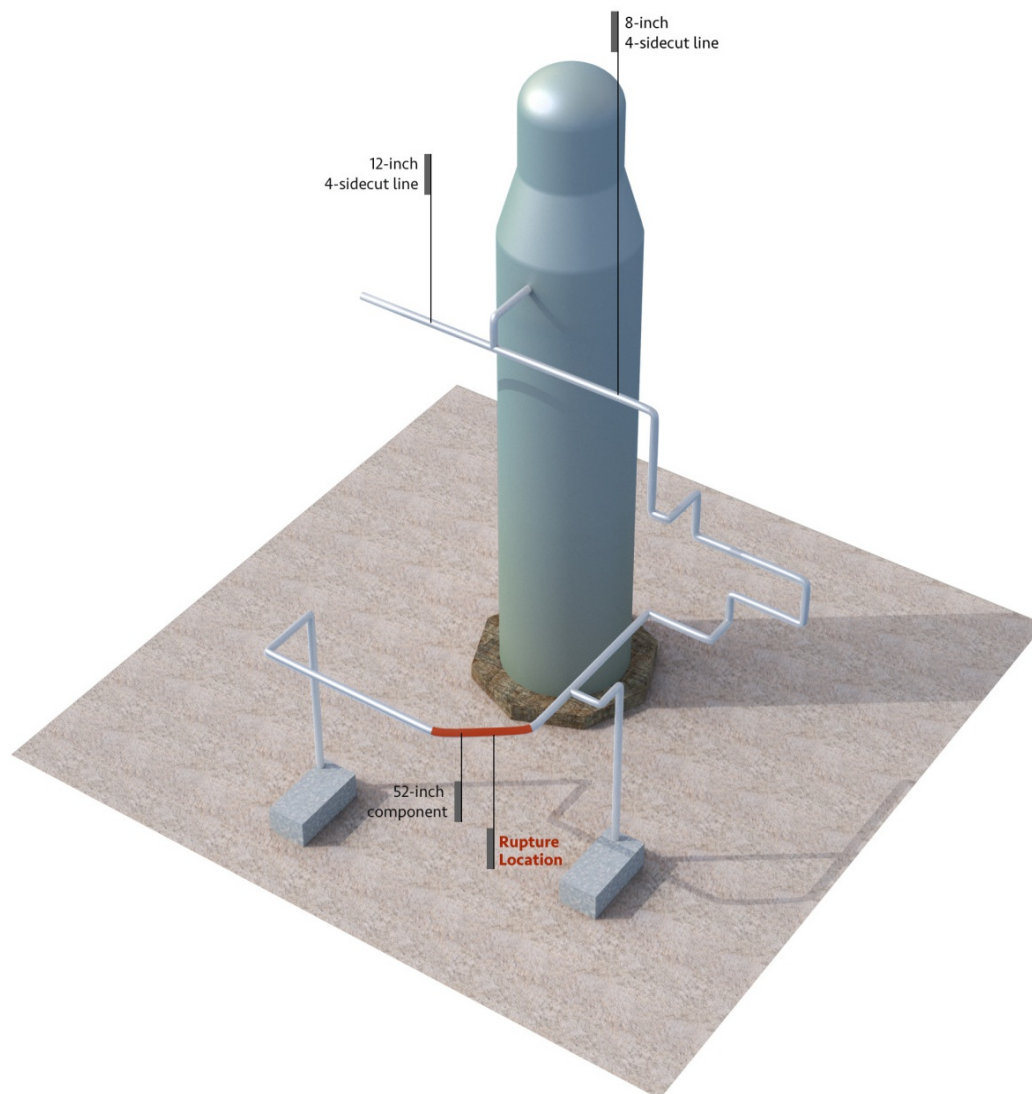
**Figure 4. 4-sidecut line configuration and rupture location.**

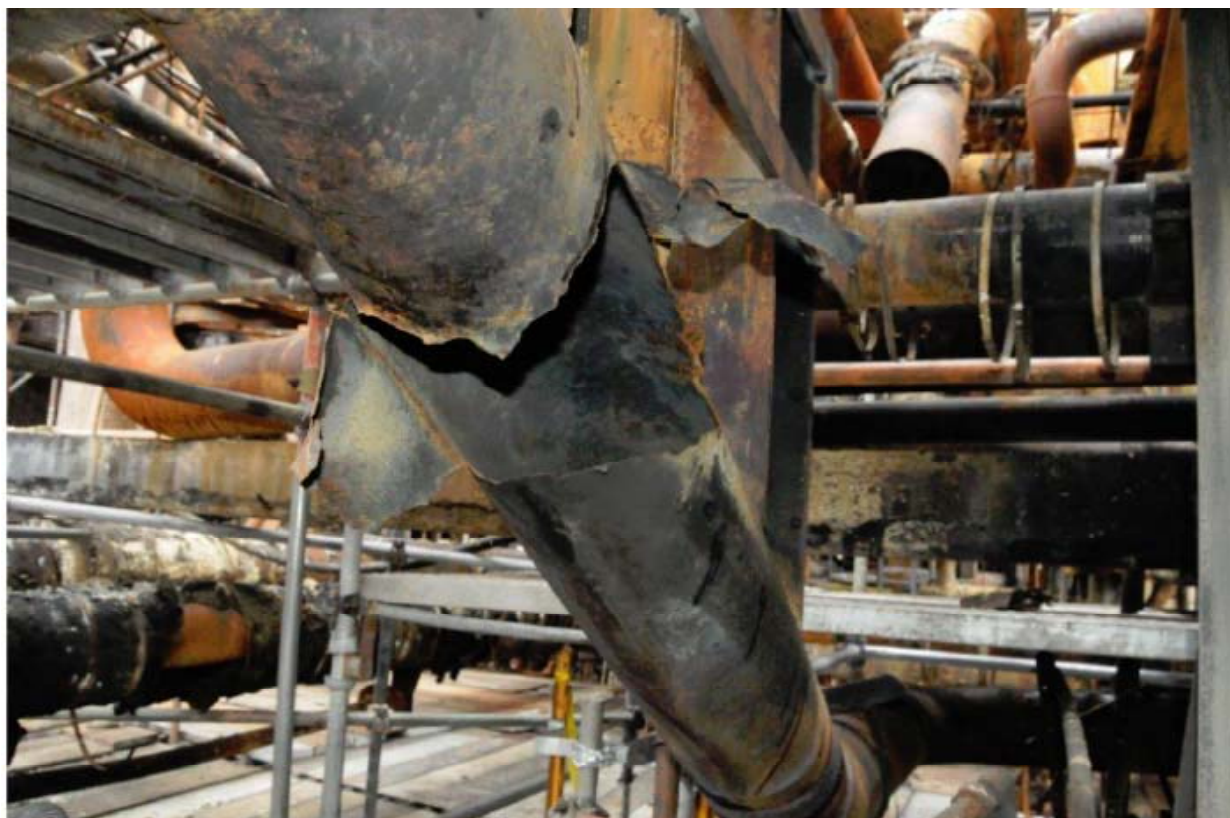
**Figure 5. Photo of rupture on 4-sidecut 52-inch component.**

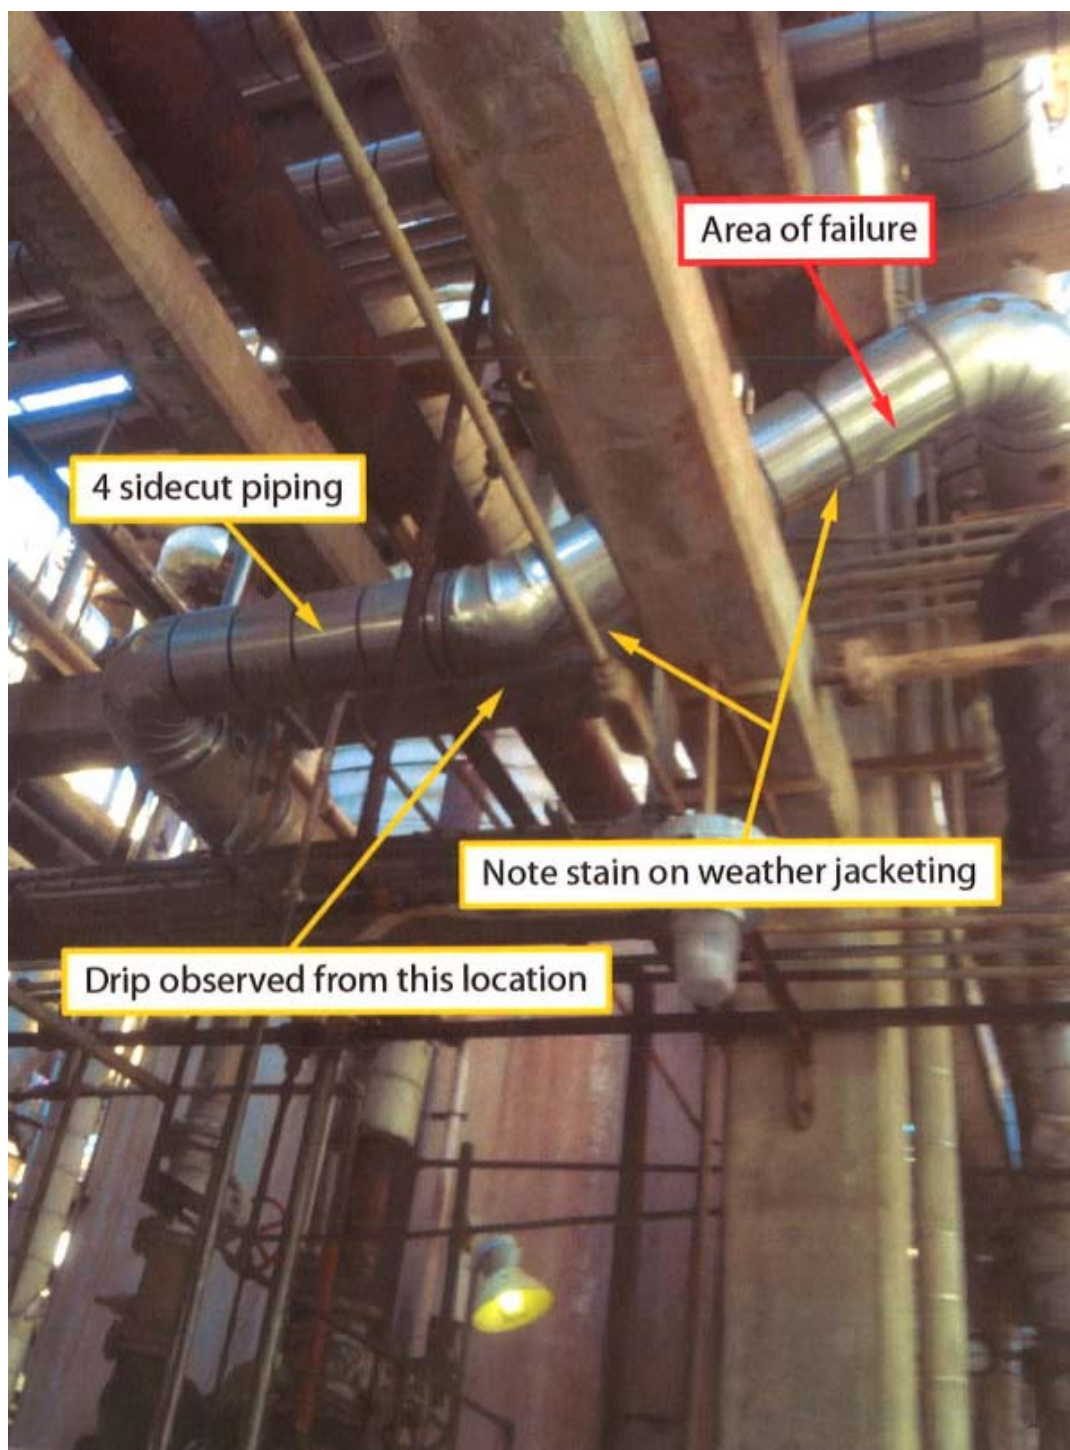
Figure 7. Photo taken of the leaking 4-sidecut pipe on August 6, 2012, at the Chevron Richmond Refinery.<sup>49</sup> Insulation obscured the actual leak location. Stain signifies where hydrocarbon process fluid was leaking from the 4-sidecut piping.

As the firefighters were removing the sheathing of the 4-sidecut line (shown in Figure 7), white hydrocarbon vapor visibly began to emerge from under the now-exposed insulation material. The firefighters continued to remove the sheathing despite the formation of hydrocarbon vapor. During the continued sheathing removal, insulation that was soaked with hot 4-sidecut hydrocarbon autoignited once exposed to oxygen—only feet from the firefighters. The hose teams immediately put out the fire, and both firefighters quickly came down from the scaffold (Figure 11).

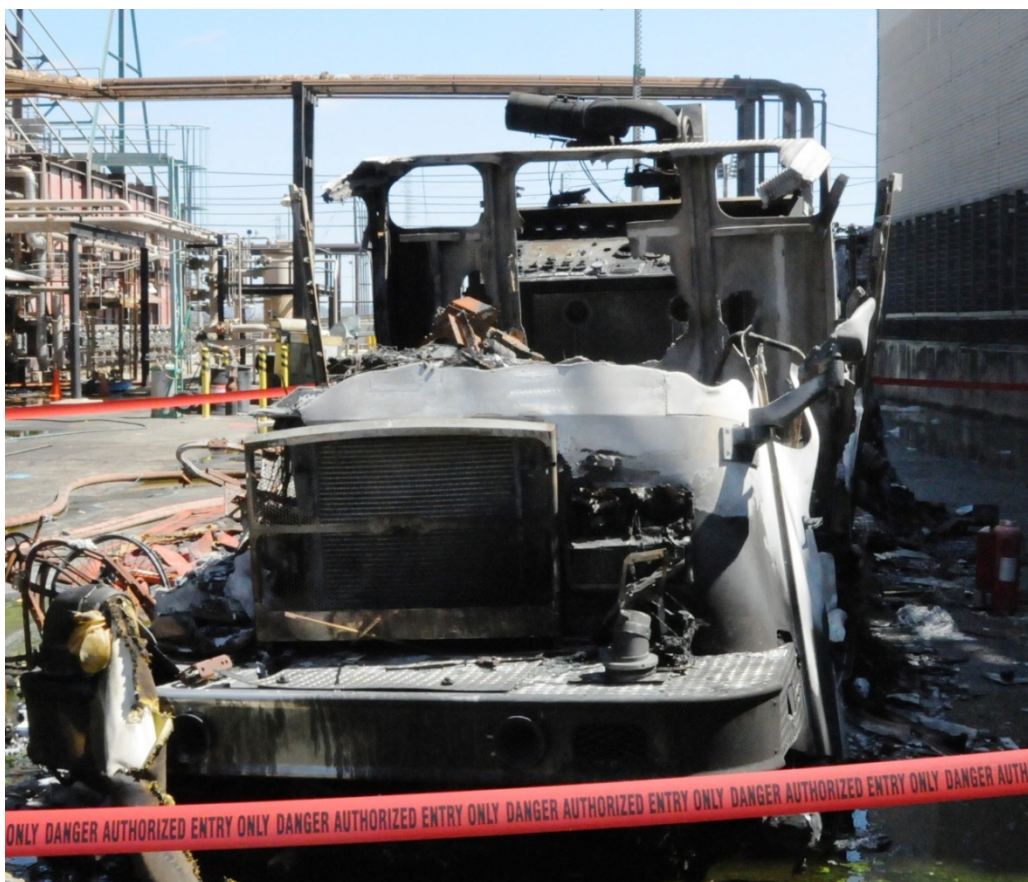
**Figure 14. Photo of the burned remains of the fire truck that was consumed by the fire. A firefighter was in the cab when the light gas oil ignited. The fire truck was positioned in the cold zone approximately 65 feet from the leak location.**

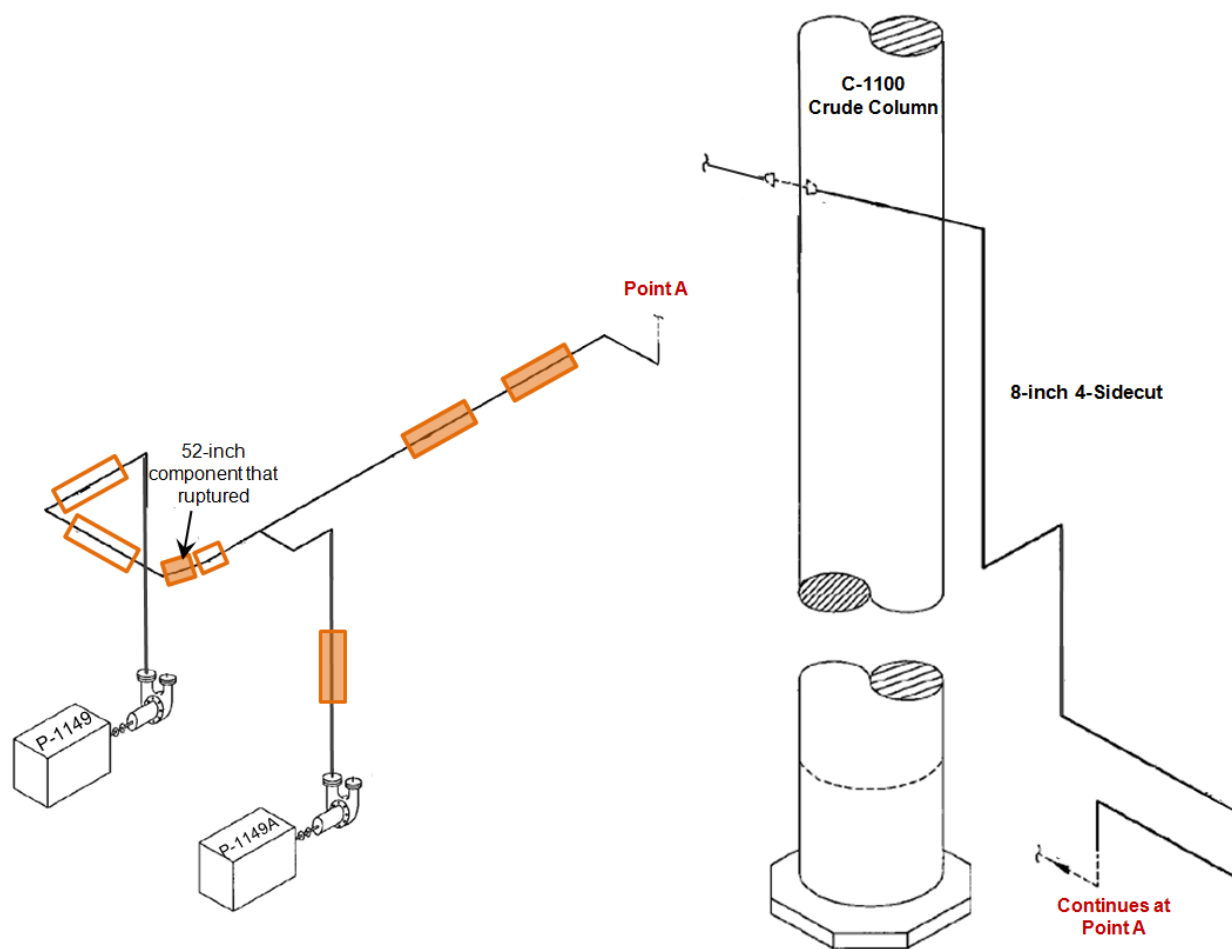
**Figure 18. Locations of metallurgical samples taken from 8-inch 4-sidecut piping post-incident. The seven samples taken are boxed in orange. Four of the seven components sampled (shown with an orange fill) were found to have a silicon content less than 0.10 weight percent.**

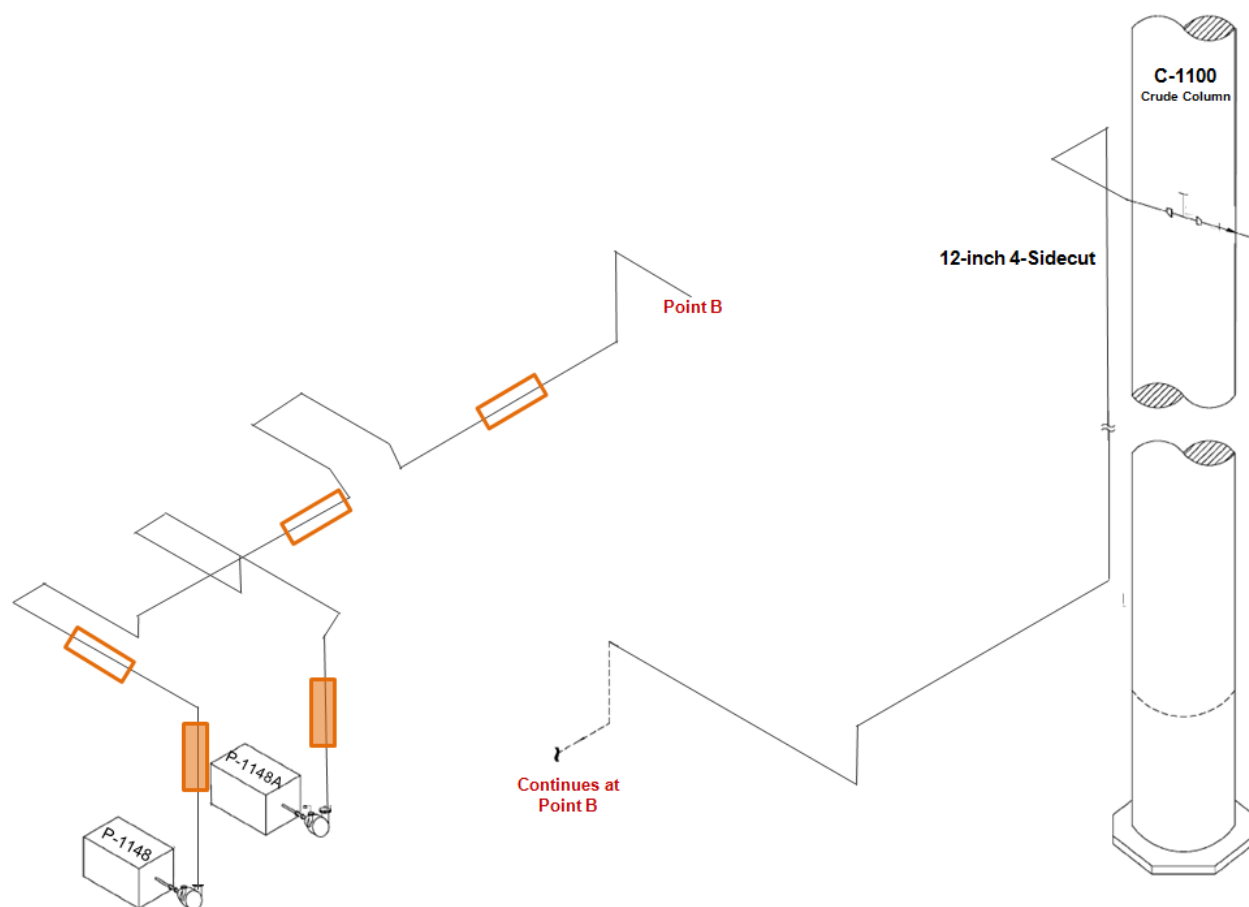
**Figure 19. Locations of metallurgical samples taken from 12-inch 4-sidecut piping post-incident. The five samples taken are boxed in orange. Two of the five components sampled (shown with an orange fill) were found to have a silicon content less than 0.10 weight percent.**

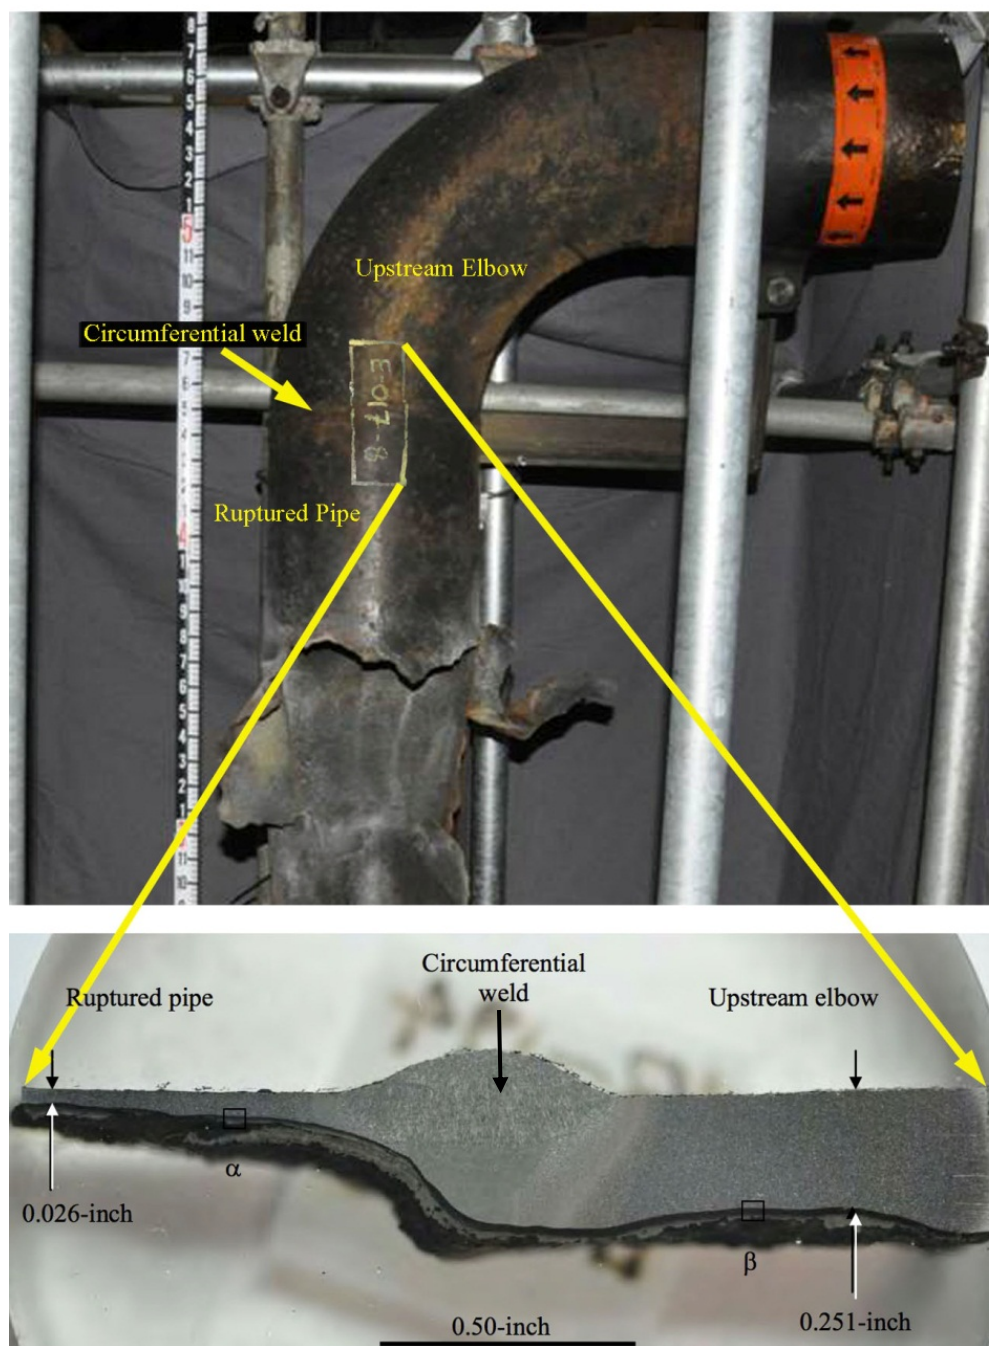
**Figure 20. 4-sidecut piping sample (E-017-8) analyzed by Anamet Labs showing the relative thickness of low silicon piping on the left and the high silicon piping on the right. The ruptured 52-inch pipe component (left) contained 0.01 weight percent silicon, and the upstream elbow component (right) contained 0.16 weight percent silicon.<sup>75</sup> The initial nominal thickness of this piping was 0.322-inch.**

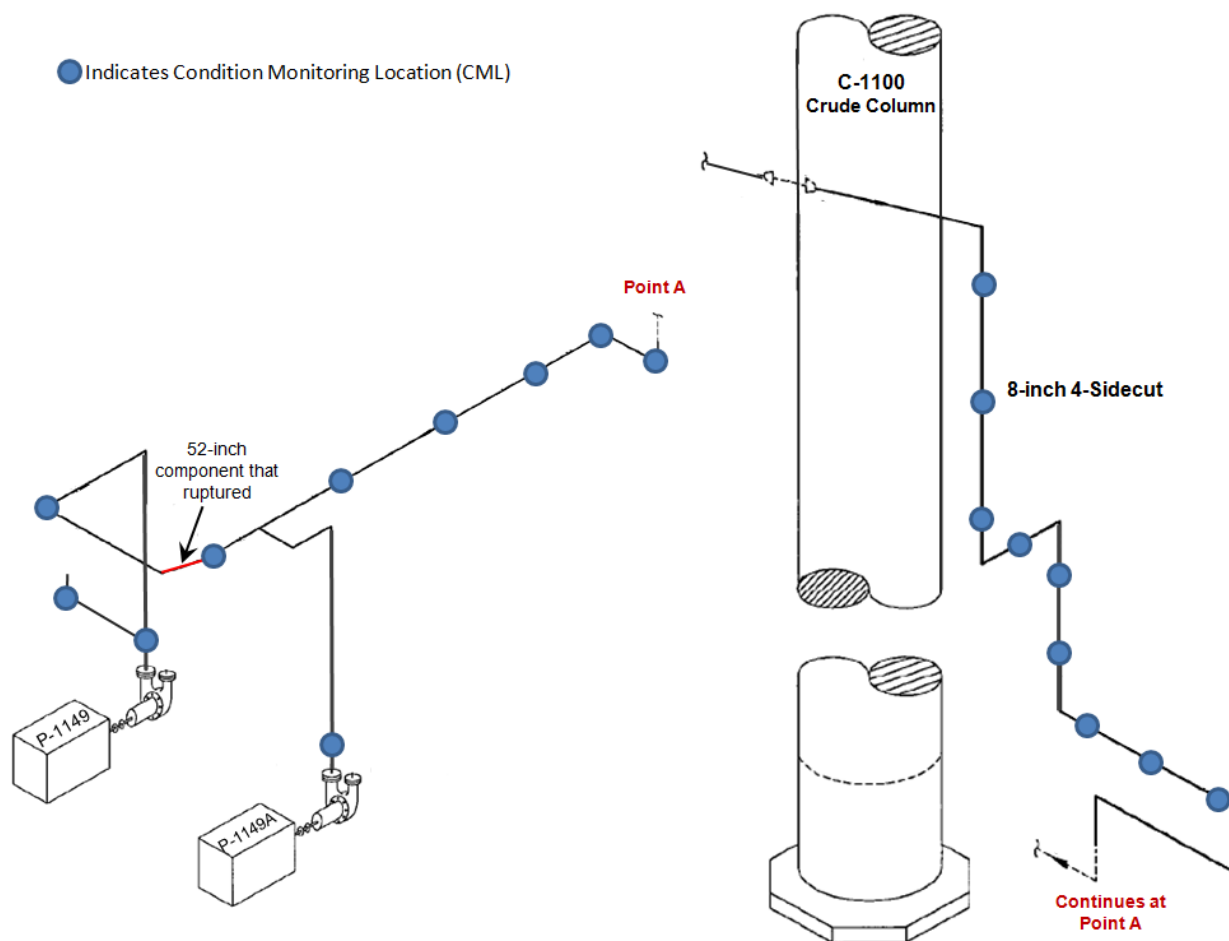
the 8-inch 4-sidecut piping circuit, although 100 percent component inspection was not performed. The CSB found that, although a CML was located on the adjacent upstream elbow, no CMLs were placed on the low silicon piping component that failed (Figure 21). Chevron identified corrosion in the 52-inch component during a supplemental 2002 inspection,<sup>87</sup> but the inspection results were not entered into the CML-tracking portion of the inspection database, and no new CML was required to be added to ensure future monitoring. As a result, the 52-inch component was never inspected again (Section 5.1.2.1.1).

**Figure 21. CML placement on 8-inch 4-sidecut piping. Nineteen CMLs were used to monitor corrosion rates in the 8-inch 4-sidecut piping. A CML was not placed on the 52-inch component that ultimately failed. A CML was placed, however, on the upstream elbow adjacent to the 52-inch component.**

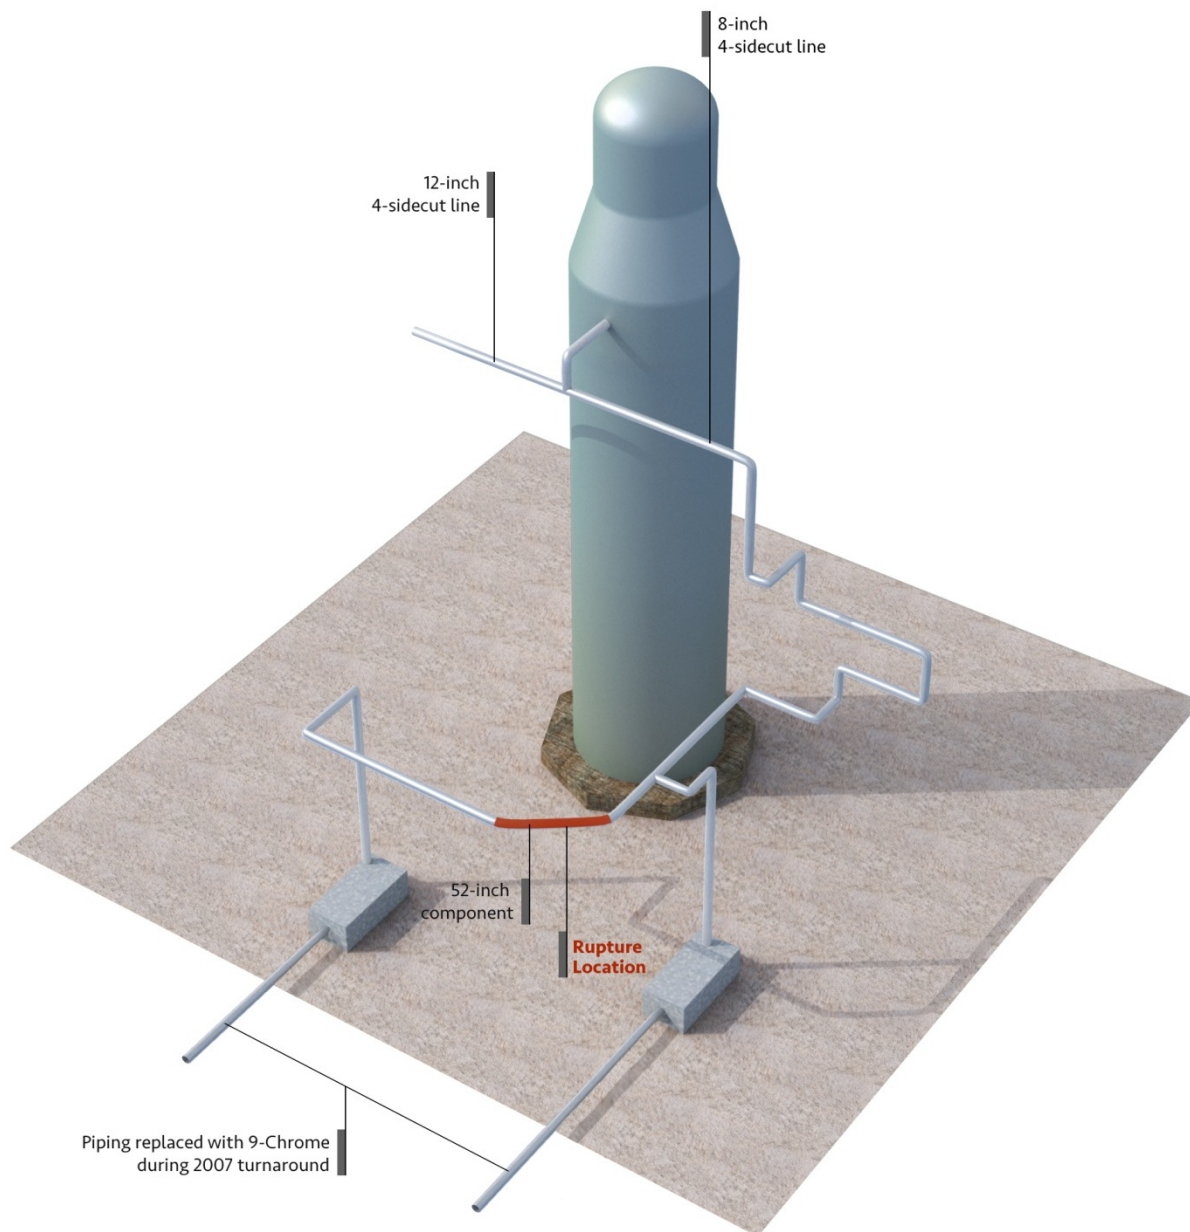
**Figure 33. Crude column schematic indicating the piping downstream of the 4-sidecut pumps that was replaced during the 2007 Crude Unit turnaround. The portion of the carbon steel line containing the component that failed on August 6, 2012 was not replaced.**

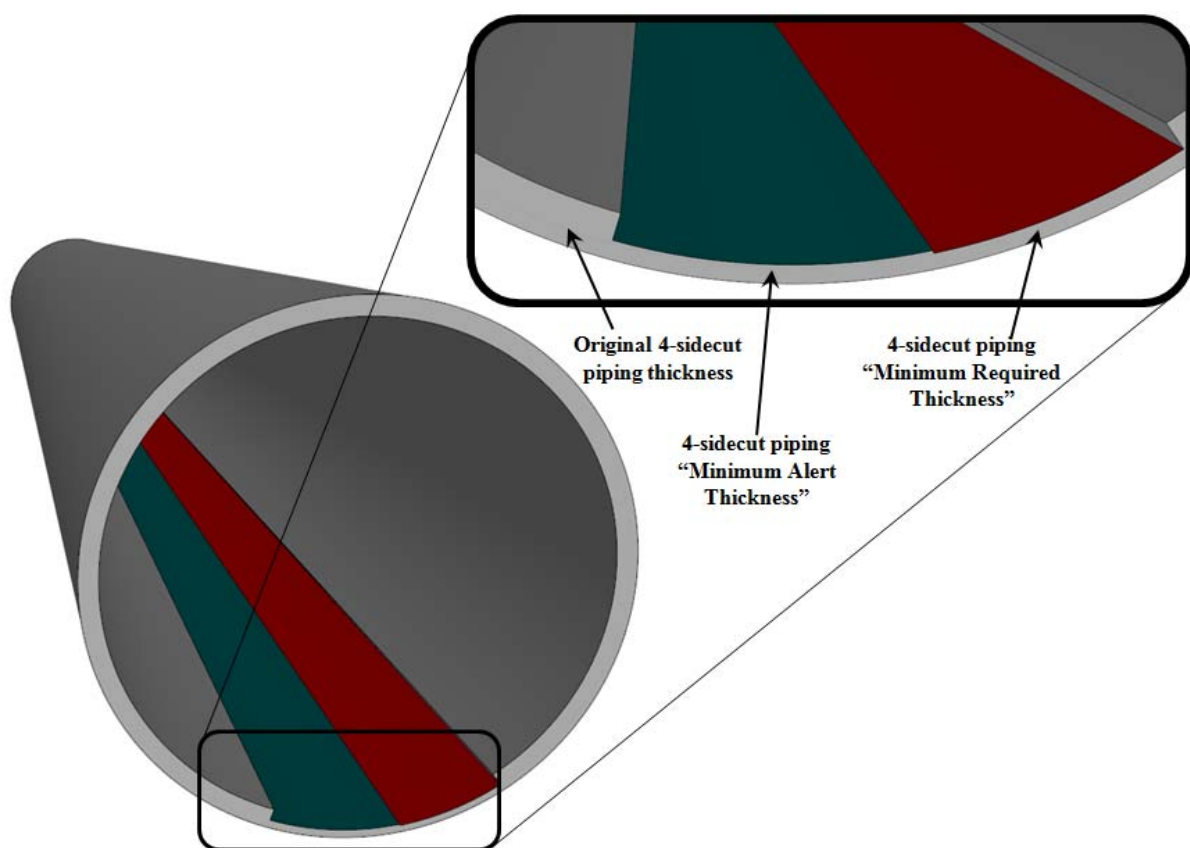
**Figure 36. To-scale schematic of 4-sidecut piping original wall thickness (0.322-inch), Minimum Alert Thickness (0.13-inch), and Minimal Required Thickness (0.11-inch) using API RP 574 default values.**

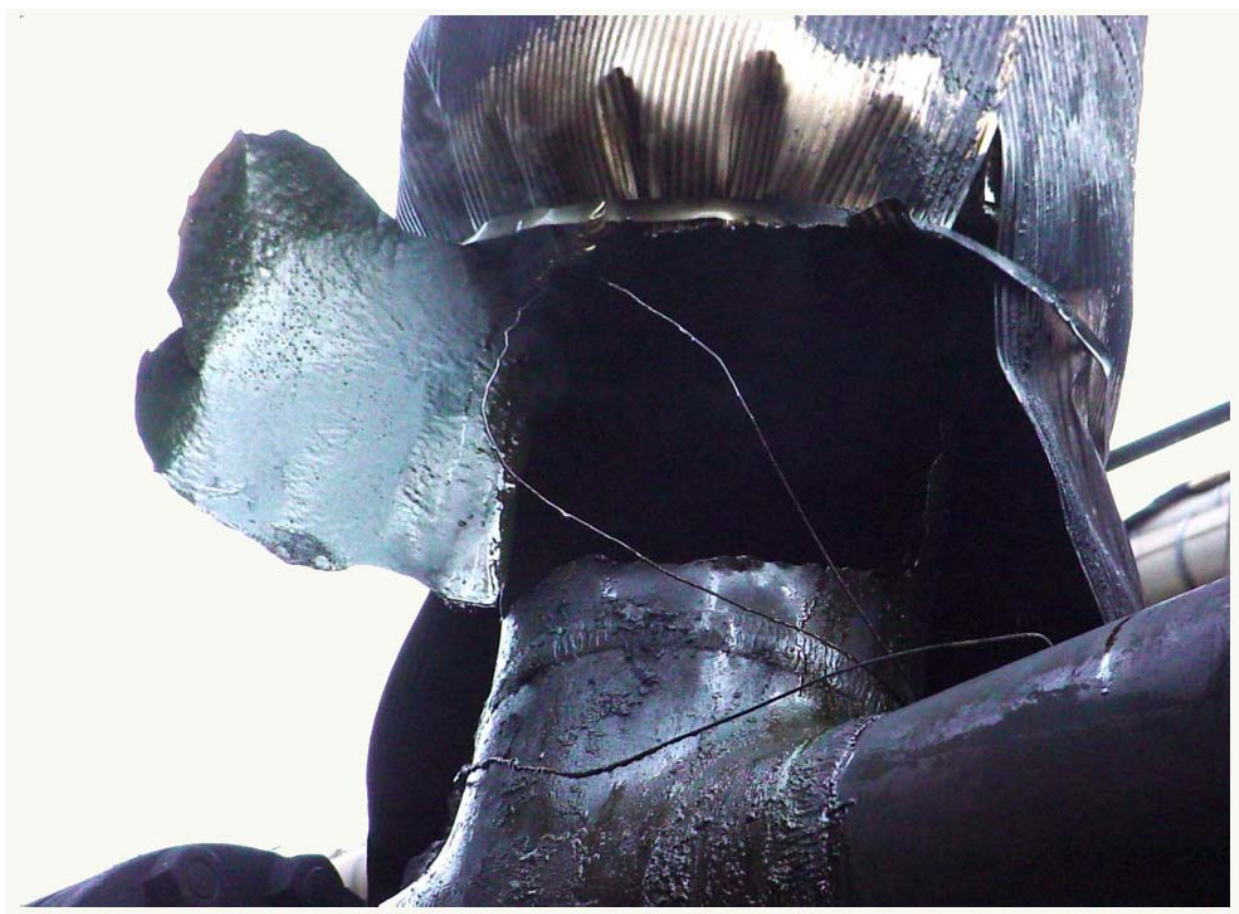
**Figure 38. Photo from API RP 939-C of a low-silicon pup piece that ruptured at a BP refinery. The surrounding piping had higher silicon content, and the pup piece’s accelerated corrosion rate was unmonitored.**

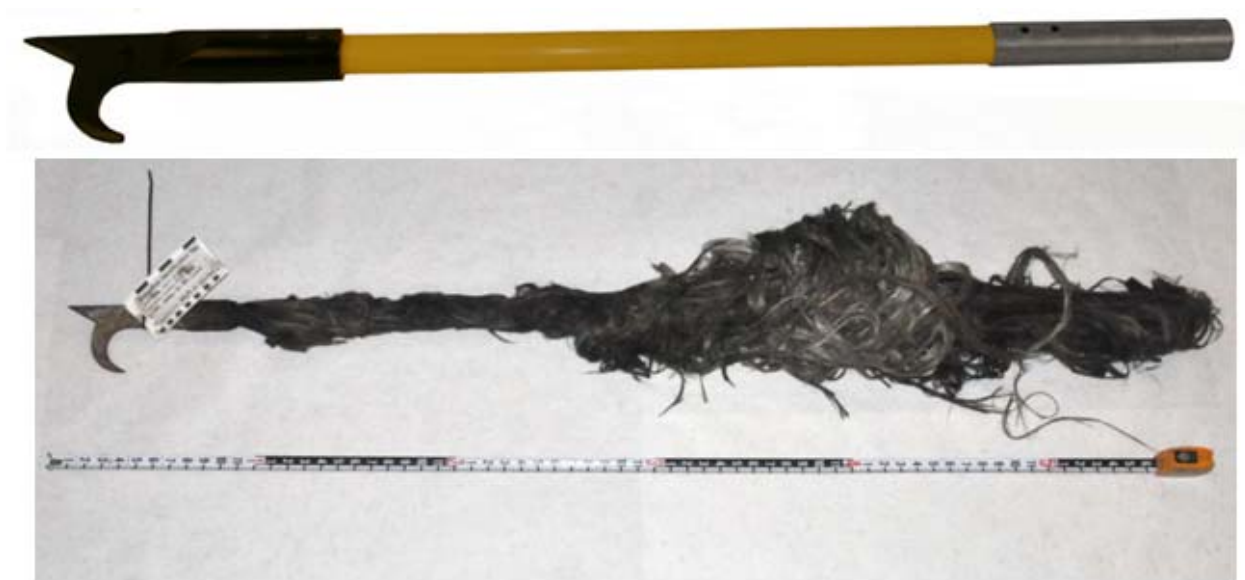
**Figure 40. Photo of undamaged<sup>179</sup> (top) and burned during incident (bottom) pike pole used in early attempts to remove 4-sidecut insulation.**

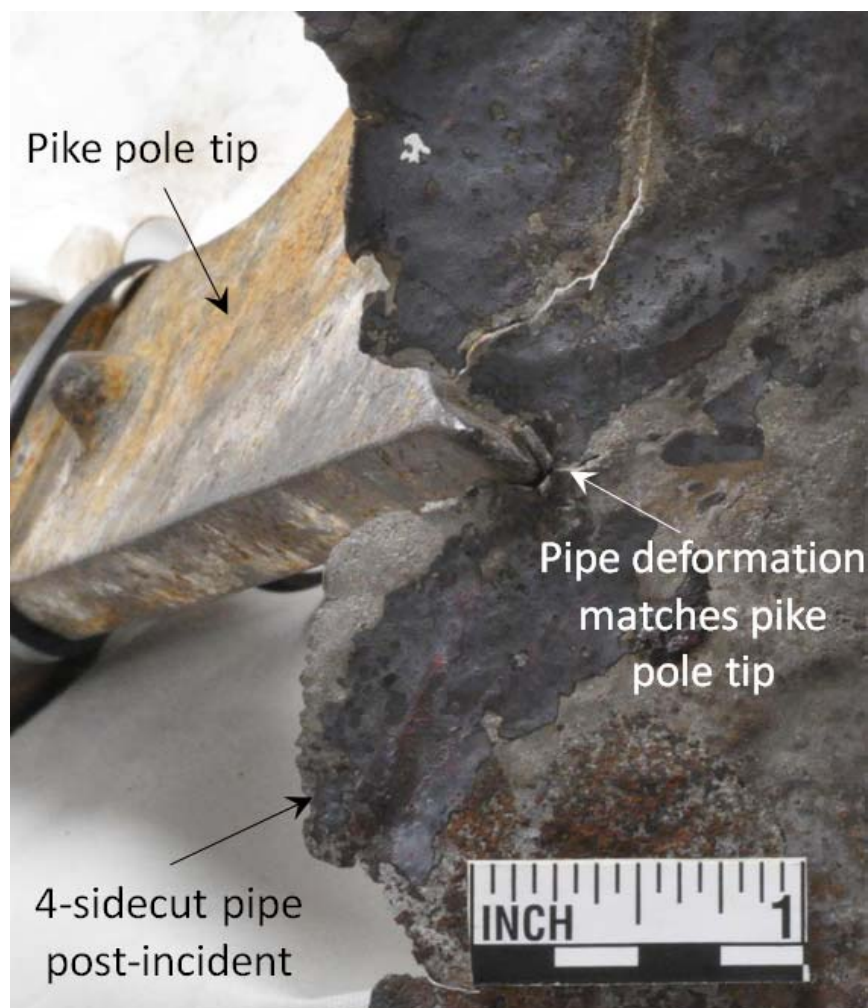
**Figure 41. Photo showing that tip of fire pole matches apparent puncture location in failed 52-inch component of 4-sidecut piping.**
