# FINAL INVESTIGATION REPORT

## CHEVRON RICHMOND REFINERY PIPE RUPTURE AND FIRE

### CHEVRON RICHMOND REFINERY #4 CRUDE UNIT RICHMOND, CALIFORNIA

AUGUST 6, 2012

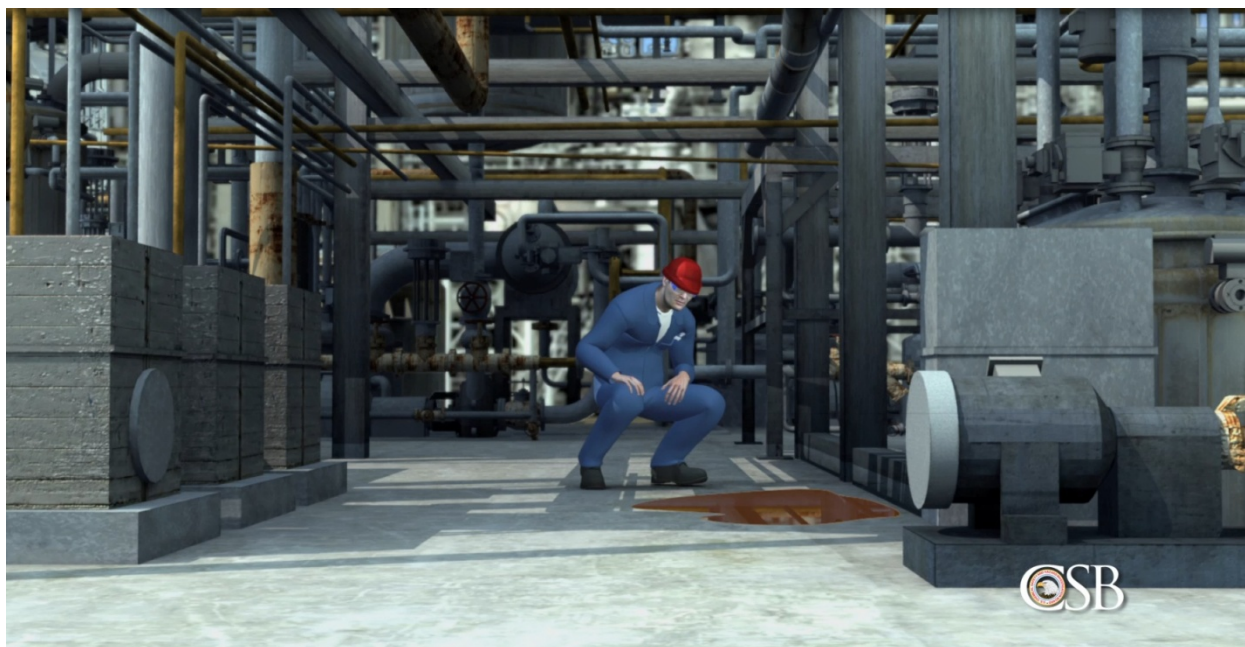
At approximately 3:50 p.m. on August 6, 2012, an outside operator performing routine checks of piping and equipment found an 18-inch puddle of what appeared to be a diesel-like material on the refinery concrete pad (Figure 6). Identifying that the leak was occurring from overhead, the operator observed intermittent drips as they accumulated on the underside of an insulated pipe 14 feet above ground level. The leaking pipe was identified to be a portion of the 4-sidecut piping that originated on the Crude Column. Visually analyzing the piping, the operator determined that the line could not be isolated from the process.

**Figure 6. CSB animation depicting operator identifying the leaking 4-sidecut pipe.**

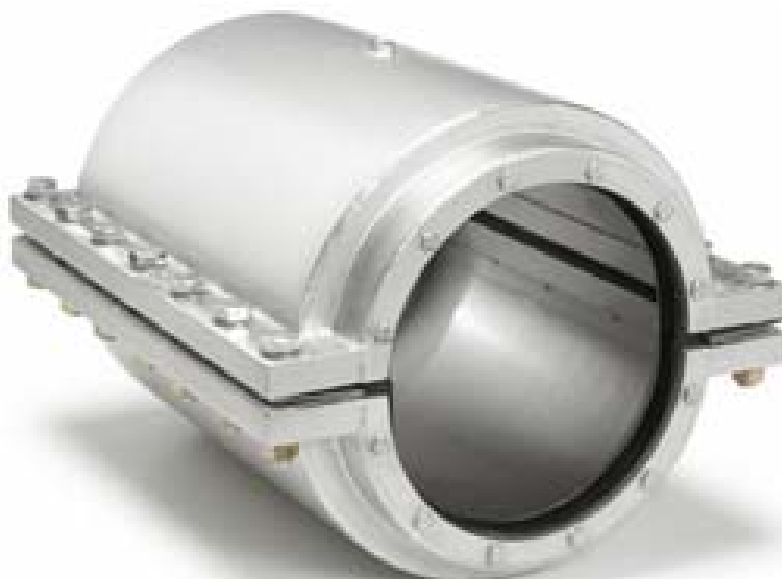
Ultimately, a large group of Chevron employees—40 people in total throughout the hours leading to the incident—accumulated at the leak location. They began discussing their options to mitigate or stop the leak. The inspectors informed the group that the 4-sidecut pipe walls were thinning due to sulfidation corrosion, but data collected as recently as two months prior indicated the 4-sidecut line had sufficient wall thickness to last until the next turnaround in 2016. This assessment led the group to believe that a localized mechanism, such as abrasion on the line from a pipe support near the dripping location, was the likely cause of the leak. The group then called the leak repair contractor to the leak location to assess the possibility of clamping the line in an effort to stop the leak. A photo of a typical leak repair clamp is shown in Figure 9.

**Figure 9. Example leak repair clamp for piping.<sup>50</sup> It is installed over the leak location to prevent process fluid leakage to the atmosphere.**

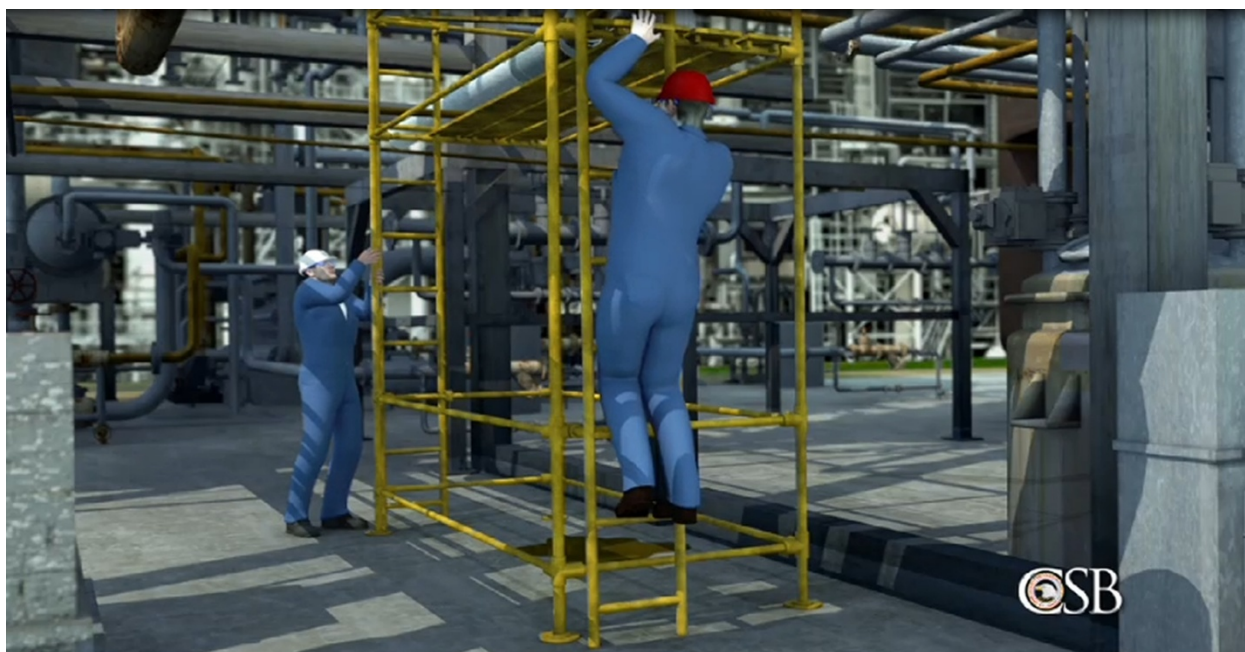
Contractors arrived at the scene to build the scaffold (Figure 10). During a pre-response safety meeting consisting of the Incident Commander, a safety officer, firefighters, and key operations personnel, one group of firefighters operating a hose was directed to spray the scaffold builders should an incident occur, and the other group of firefighters operating the second hose was directed to spray the pipe if needed. Three scaffold contractors then built the scaffold beneath the leaking 4-sidecut pipe.

**Figure 10. CSB animation of contractors erecting scaffolding beneath the leak location.**

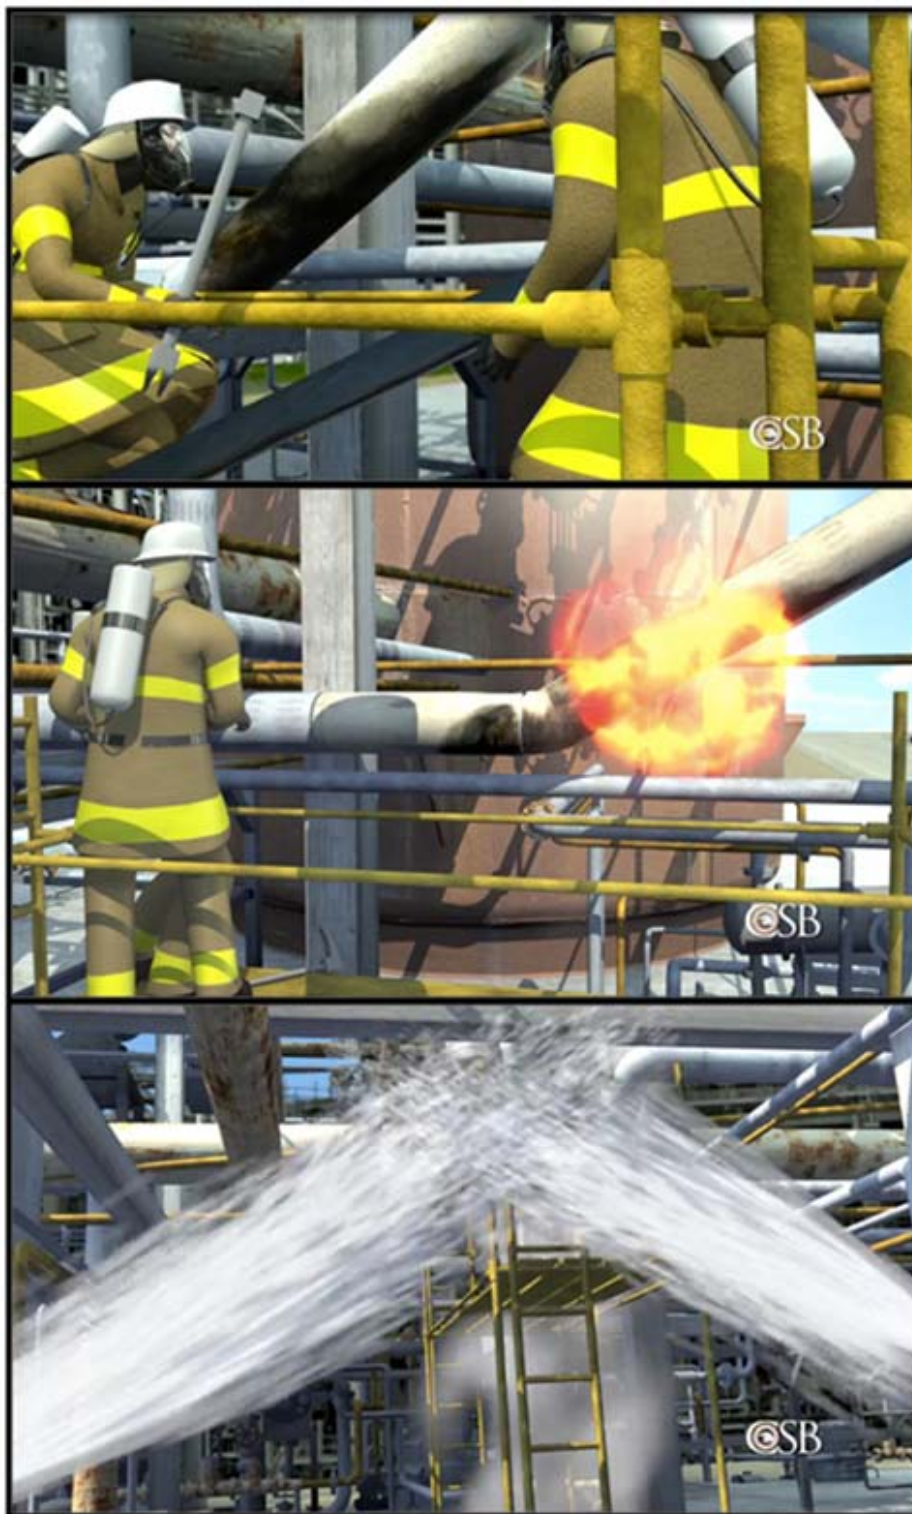
As the firefighters were removing the sheathing of the 4-sidecut line (shown in Figure 7), white hydrocarbon vapor visibly began to emerge from under the now-exposed insulation material. The firefighters continued to remove the sheathing despite the formation of hydrocarbon vapor. During the continued sheathing removal, insulation that was soaked with hot 4-sidecut hydrocarbon autoignited once exposed to oxygen—only feet from the firefighters. The hose teams immediately put out the fire, and both firefighters quickly came down from the scaffold (Figure 11).

**Figure 11.** CSB animation of firefighters attempting to remove the 4-sidecut insulation, the resulting fire, and fire extinguishing.

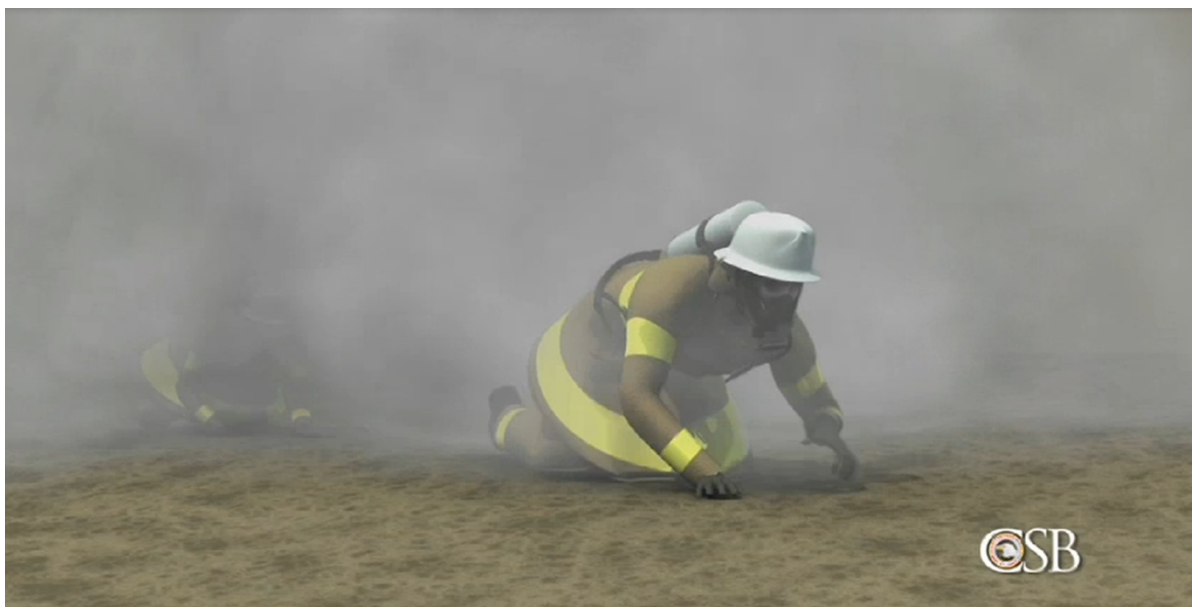
Each person engulfed in the cloud began working their way out of the vapor cloud. Several of the firefighters operating the two hoses dropped to their hands and knees to follow their hose lines to safety, feeling their way out of the cloud (Figure 12).

**Figure 12. CSB animation of firefighters who dropped to their hands and knees to escape the vapor cloud.**

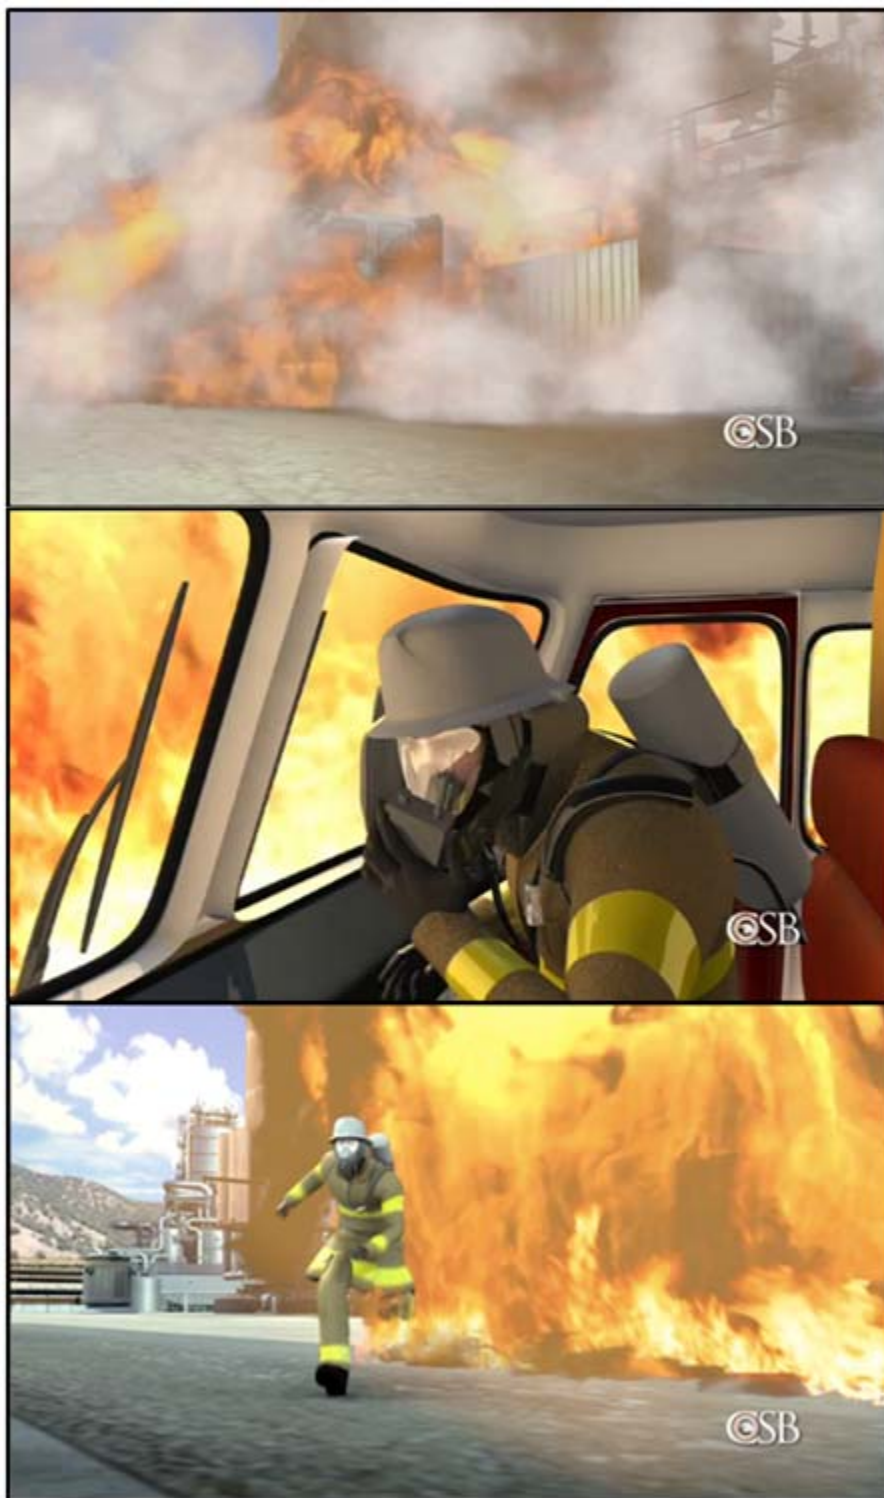
At approximately 6:30 p.m., two minutes after the large vapor cloud formed, the light gas oil ignited.<sup>53</sup> Eighteen employees safely escaped from the cloud just before ignition. One employee, a firefighter, was inside a fire engine that was engulfed in the fireball when the light gas oil ignited (Figure 13 and Figure

14). He told CSB interviewers, "... All I could see [was] heavy hydrocarbon-type boiling fire in every window of that truck. I can't even begin to describe how hot it was. It was very intense." He called "MAYDAY" over his radio but received no response. He informed the CSB, "I figured that everybody else was dead." Because he was wearing full body firefighting protective equipment, he was able to escape through the flames surrounding the fire truck and make his way to safety without physical injury.

Figure 13. CSB animation of firefighter who was inside the fire engine when the light gas oil ignited.

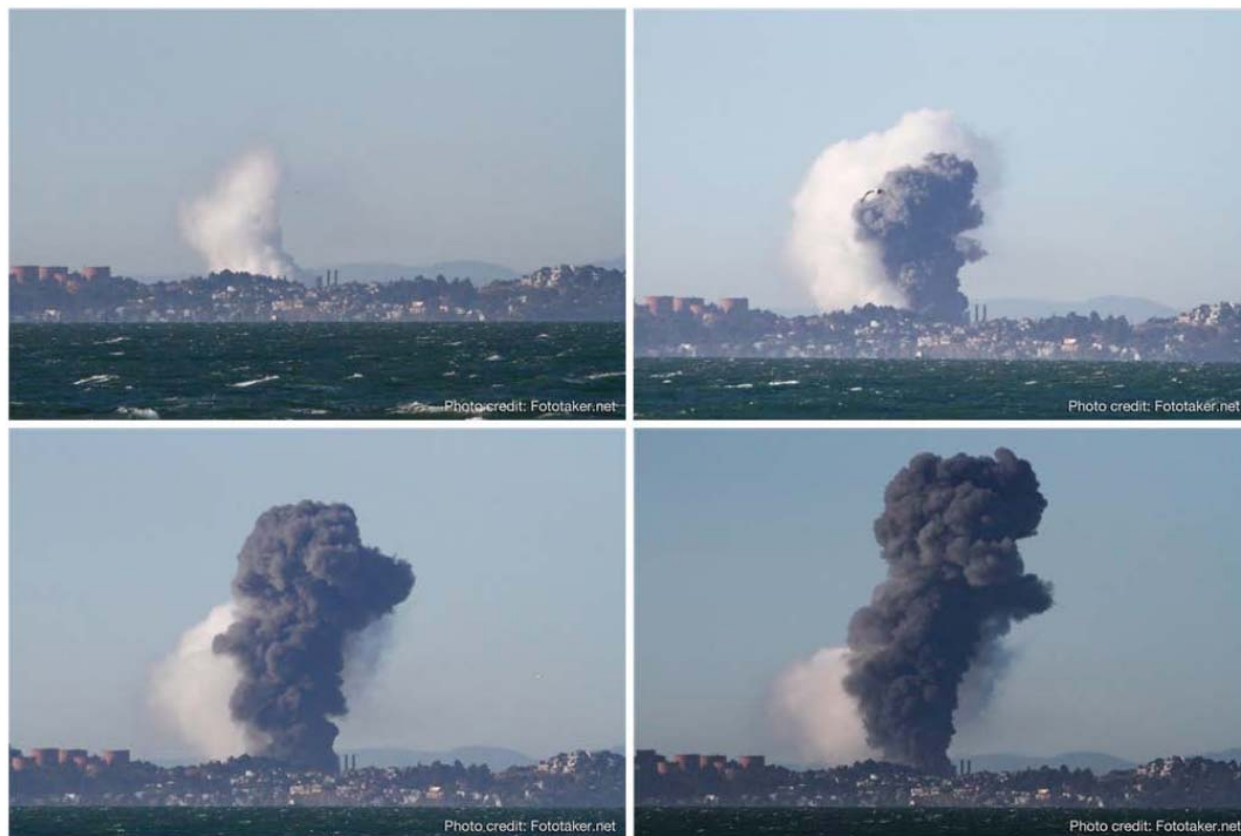
The leak resulted in a large plume of vapor which traveled across the surrounding area. The ignition and subsequent burning of the hydrocarbon process fluid created a large black cloud of smoke, which also swept across the surrounding area (Figure 15). This situation resulted in a Community Warning System (CWS) Level 3 alert,<sup>54</sup> and a shelter-in-place<sup>55</sup> advisory (SIP) was issued at 6:38 p.m.<sup>56</sup> for Richmond, San Pablo, and North Richmond. It was lifted later that night at 11:12 p.m. after the fire was fully under control. In the weeks following the incident, nearby medical facilities received over 15,000 members of the public seeking treatment for ailments including breathing problems, chest pain, shortness of breath,

**Figure 15. Initial vapor cloud formation (white cloud) and subsequent ignition (black smoke) as seen from a pier in San Francisco, California.<sup>57</sup>**

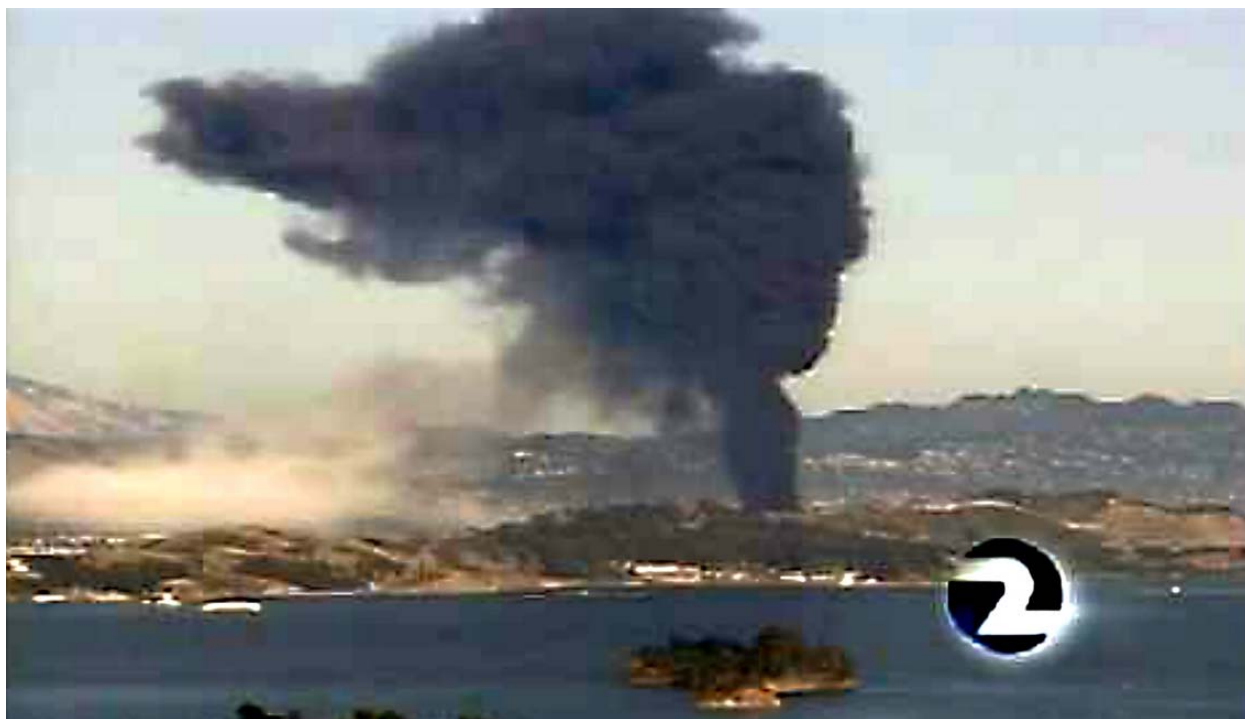
Figure 16. Vapor cloud and ignition seen from Marin County.<sup>58</sup>

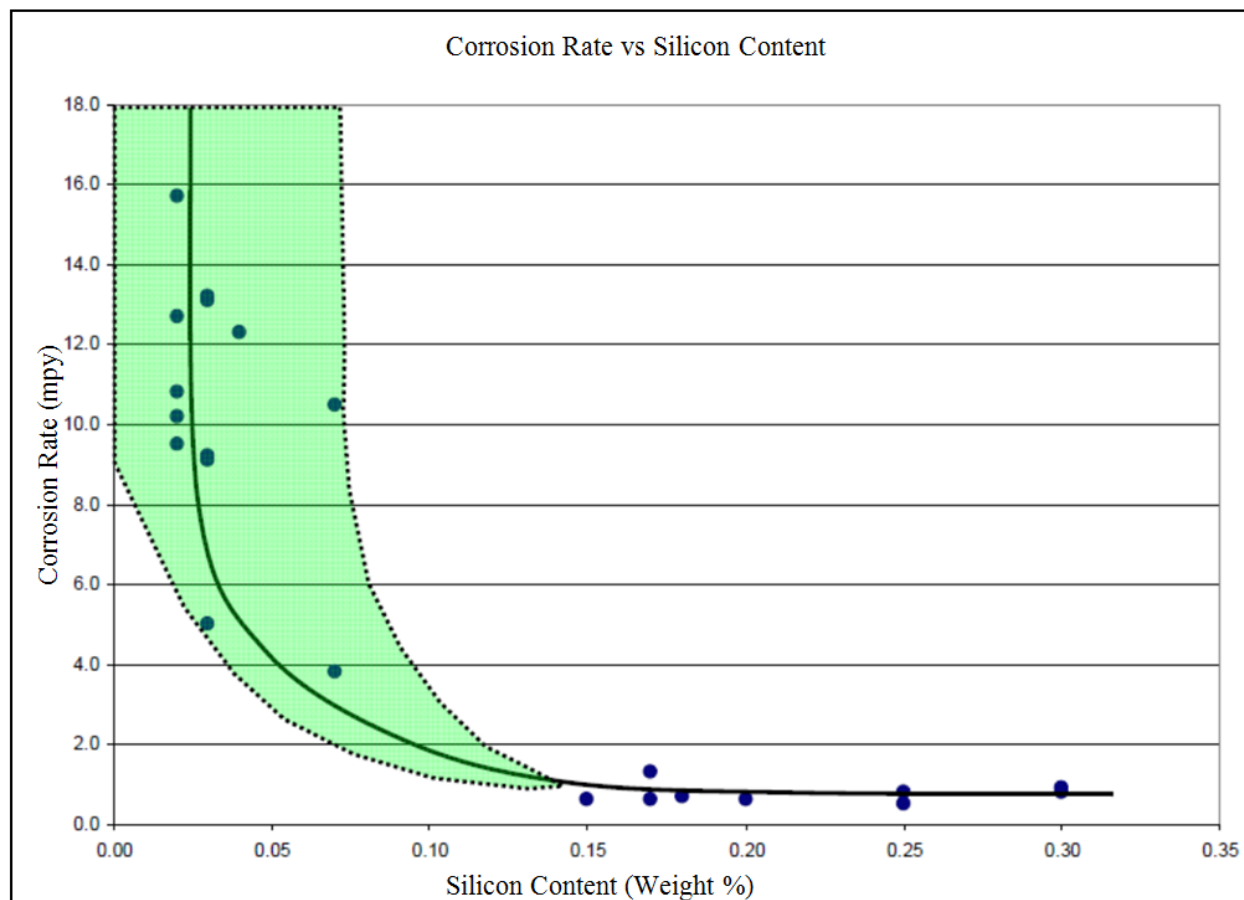
Sulfidation corrodes carbon steel at a much faster rate in comparison with its effect on other materials of construction, such as steels with a higher chromium content. This issue is discussed in depth in the CSB's Interim Investigation Report of the August 6, 2012, Chevron incident.<sup>65</sup> In addition to its naturally faster rate of sulfidation corrosion when compared with higher chromium steels, carbon steel can also experience significant variation in corrosion rates due to variances in silicon content, a component used in the steel manufacturing process. Carbon steel piping containing silicon content less than 0.10 weight percent can corrode at accelerated rates,<sup>66</sup> up to 16 times faster than carbon steel piping containing higher percentages of silicon. Figure 17 shows how carbon steel corrosion rates can greatly vary depending on silicon content.

**Figure 17. Graph of sulfidation corrosion rates with respect to silicon content in carbon steel. This graph shows how corrosion rates increase in carbon steel containing decreasing percentages of silicon. This information can be found in Annex C of API RP 939-C.<sup>67</sup>**

The refining industry has been aware of increased susceptibility to sulfidation corrosion in low-silicon carbon steel piping since as early as 1974,<sup>68</sup> nearly 40 years before the August 6, 2012, incident and two years before the Chevron Crude Unit was constructed. Before the incident, Chevron documented its understanding of the potentially catastrophic nature of failures caused by sulfidation corrosion, as reflected in Chevron's *Corrosion Prevention and Metallurgy Manual*:

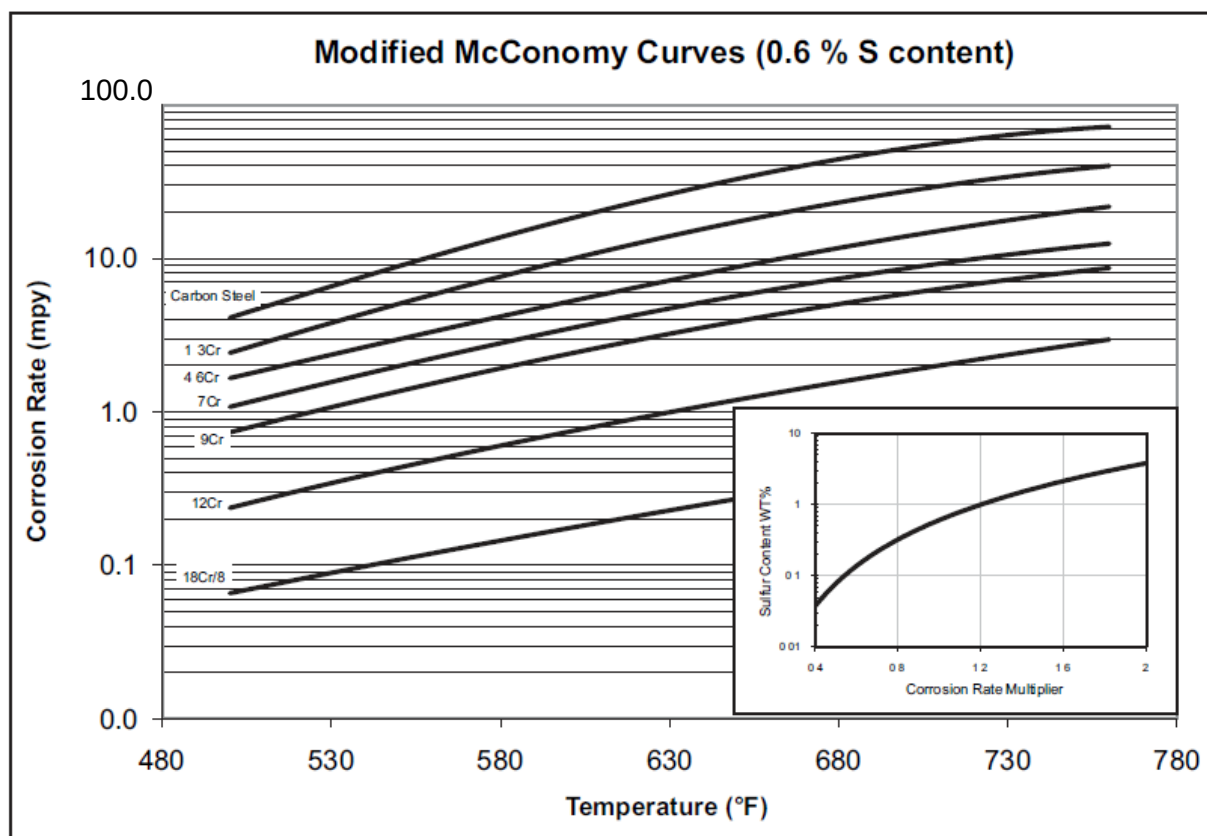
greatly reduced. Carbon steel<sup>99</sup> corrodes approximately nine times faster than 9-Chrome steel, which contains 9 percent chromium, and carbon steel corrodes approximately 120 times faster than stainless steel, which contains 18 percent chromium.<sup>100,101</sup>

Figure 22. Modified McCconomy Curves from API RP 939-C.

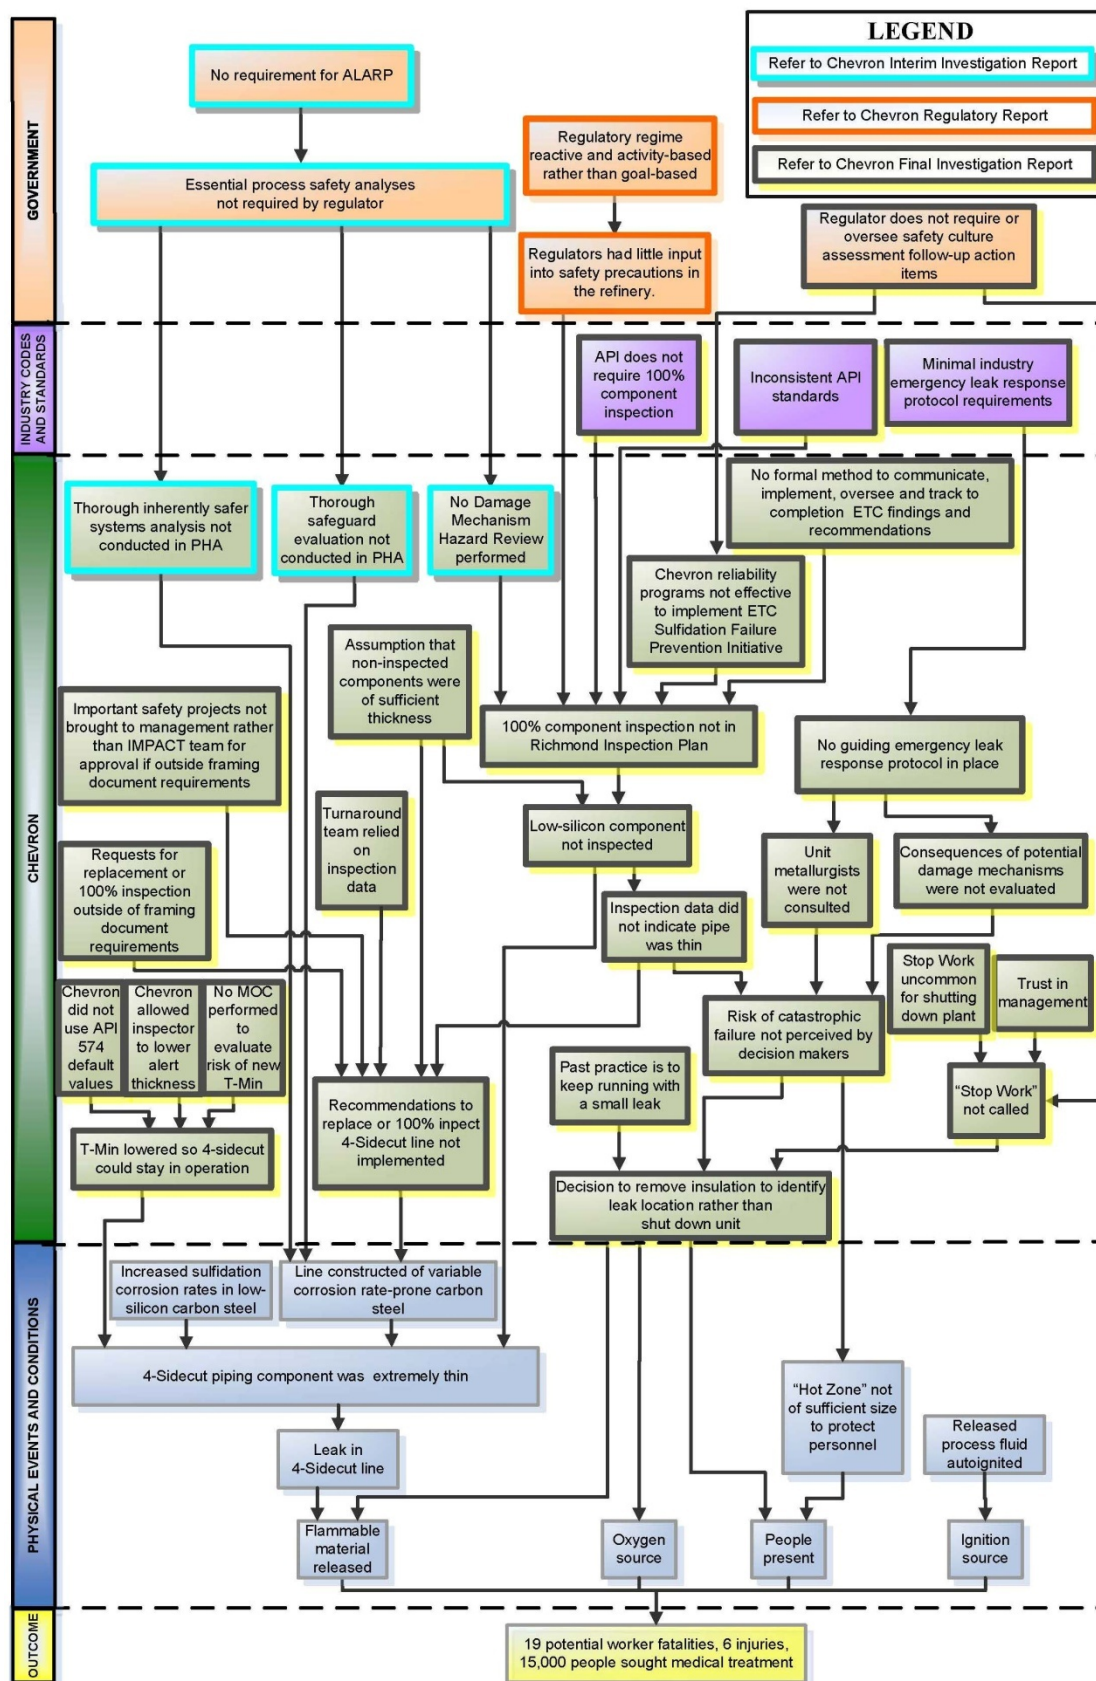
The CSB investigation team developed an accident map (AcciMap)<sup>114</sup> for the Chevron investigation (Figure 24). The AcciMap is a multilayered causal diagram that depicts immediate causes<sup>115</sup> as well as higher level contributing causes at the corporate, governmental, and regulatory levels. This diagram includes five levels:

Figure 24. Acci-Map of August 6, 2012, Chevron Refinery Fire.

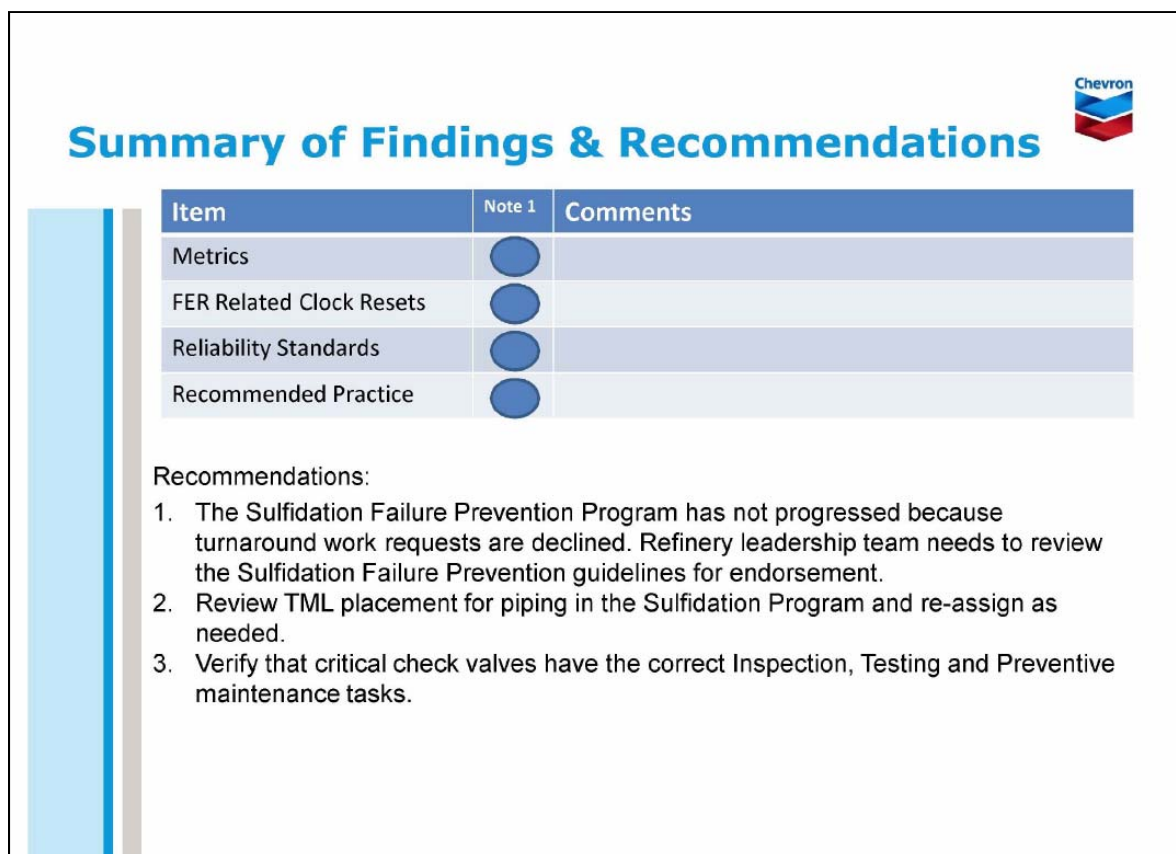
In March 2012, five months prior to the incident, the FER BIN Leader visited the Chevron Richmond refinery and identified that inspection of all carbon steel components susceptible to sulfidation corrosion was not being performed as recommended by the ETC Sulfidation Failure Prevention Initiative (Figure 35). In addition to identifying that CML placement for piping may need to be reassigned, this review found that the IMPACT team was denying critical inspection recommendations during the turnaround planning process. The FER BIN Leader identified that Richmond refinery leadership needed to review and implement the 2009 Chevron ETC Sulfidation Failure Prevention Initiative report and recommendations.

**Figure 35. Presentation slide showing corporate reliability leader's findings that the Richmond Refinery was not complying with the ETC Sulfidation Failure Prevention Initiative.**

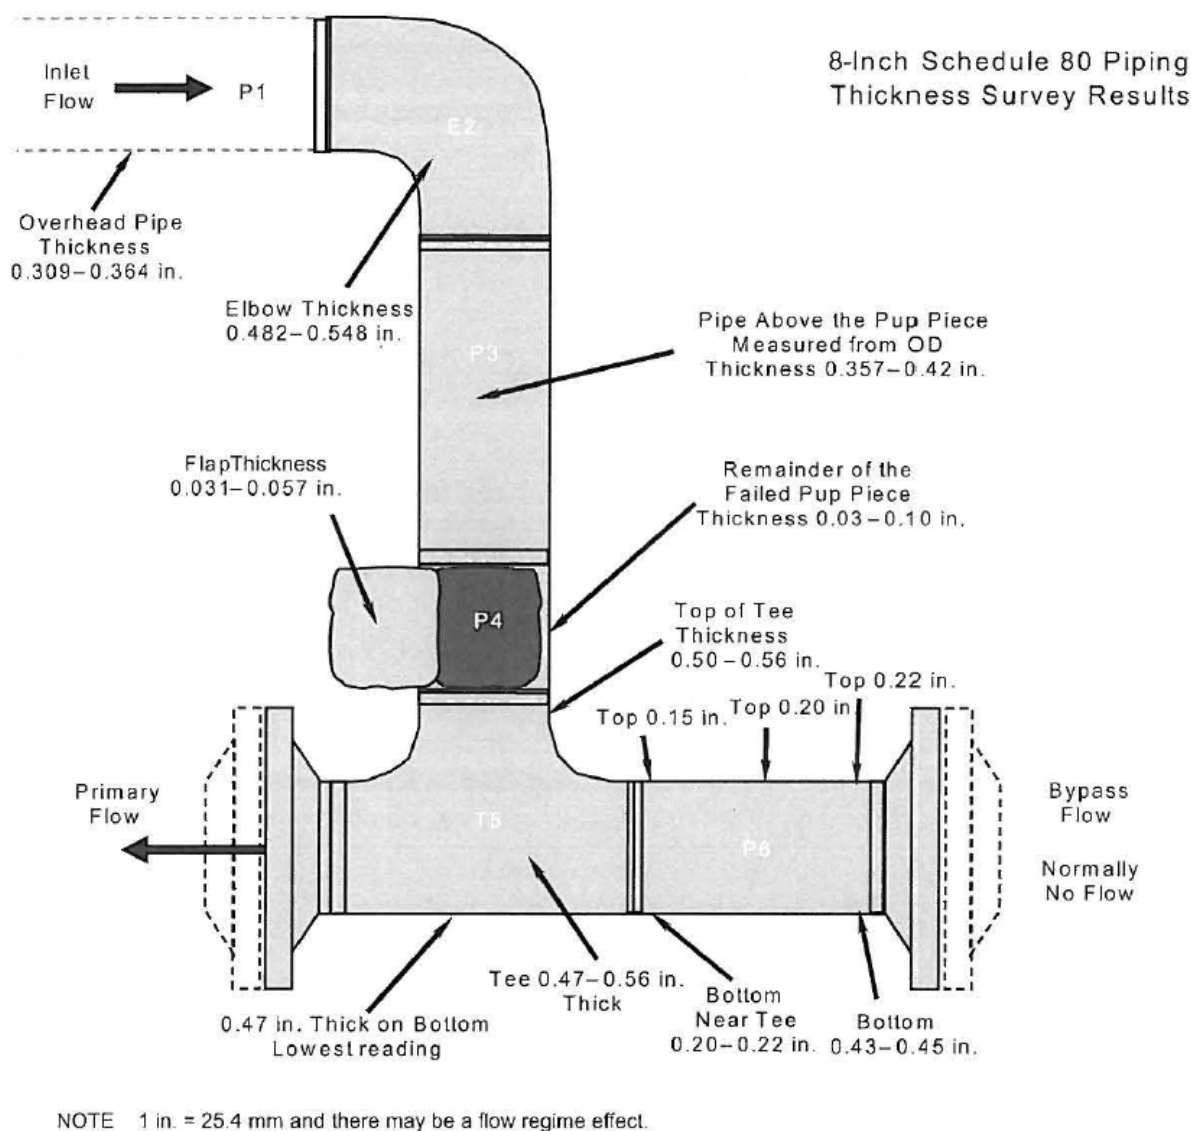
The document also communicates the risk of sulfidation corrosion failures, stating “ruptures are possible leading to the potential release of large quantities of hydrocarbon streams,”<sup>148</sup> and sulfidation corrosion “continues to be a significant cause of leaks leading to equipment replacements, unplanned outages, and incidents associated with large property losses and injuries.”<sup>149</sup> It shows an example of a rupture that occurred due to unmonitored low-silicon carbon steel components (Figure 38 and Figure 39).

**Figure 39. Schematic from *API RP 939-C* of the piping shown in Figure 38. The piping component that ruptured was significantly thinner than the surrounding piping.**

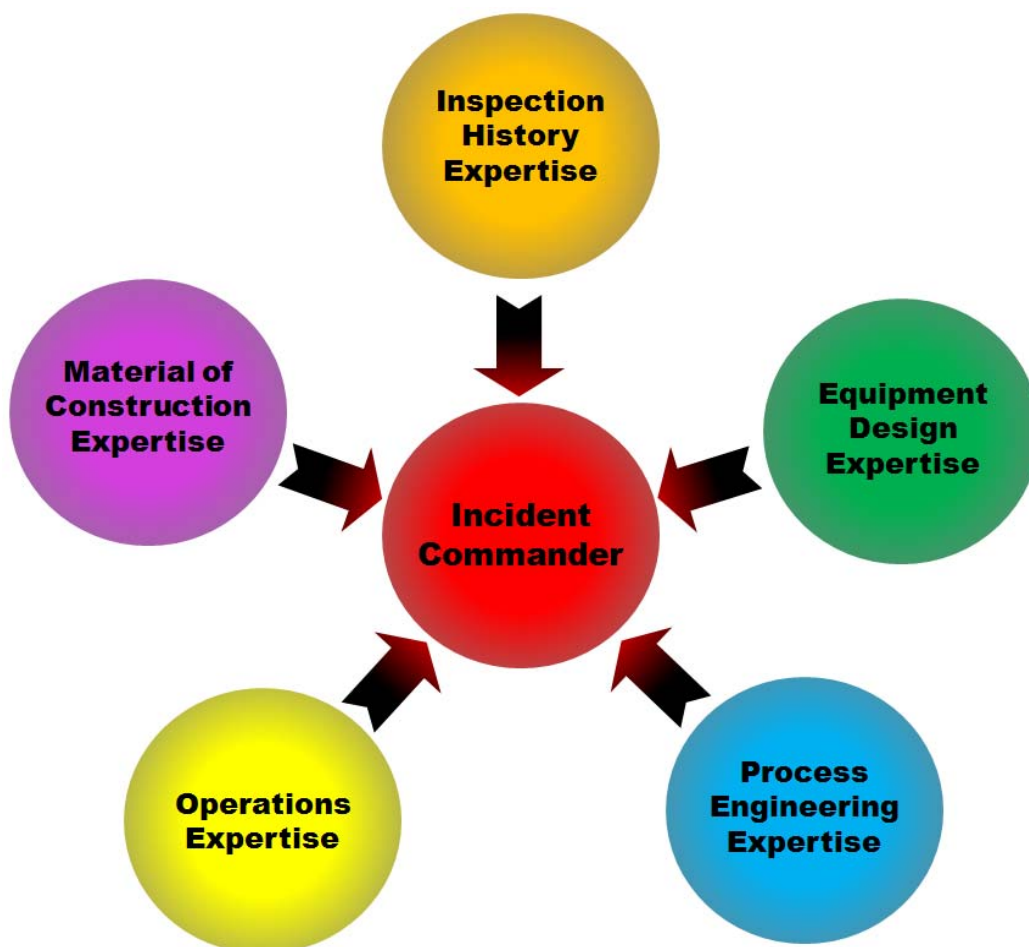
**Figure 42. Ideal communication flow to Incident Commander during refinery process fluid leak incident. In industrial process fluid leak emergency situations, it is essential that various personnel with different areas of expertise communicate their relevant knowledge to the Incident Commander.**

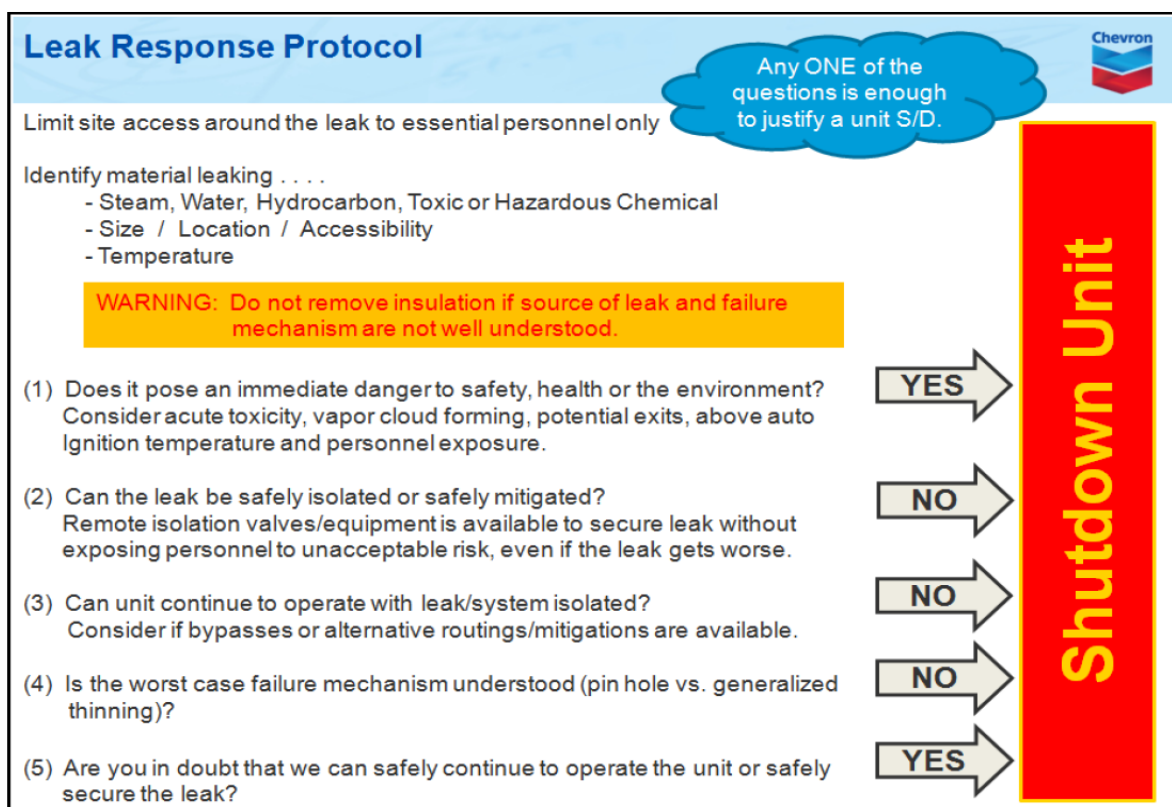
The new leak response protocol also provides examples of scenarios when it is required to shut down the unit. (See Figure 43) Effectively using it greatly reduces some of the inherent human factors concerns at play when invoking Stop Work Authority, as discussed in Section 5.1.7.

**Figure 43. Chevron's new Leak Response Protocol, developed post-incident. The new protocol advises plant personnel on when to shut down a unit due to a piping or equipment leak.**
