# ***DOING IT RIGHT***

## ***COLSTRIP'S BRIGHT FUTURE WITH CLEANUP***

*A joint research effort between Northern Plains Resource Council  
and International Brotherhood of Electrical Workers (Local 1638)*

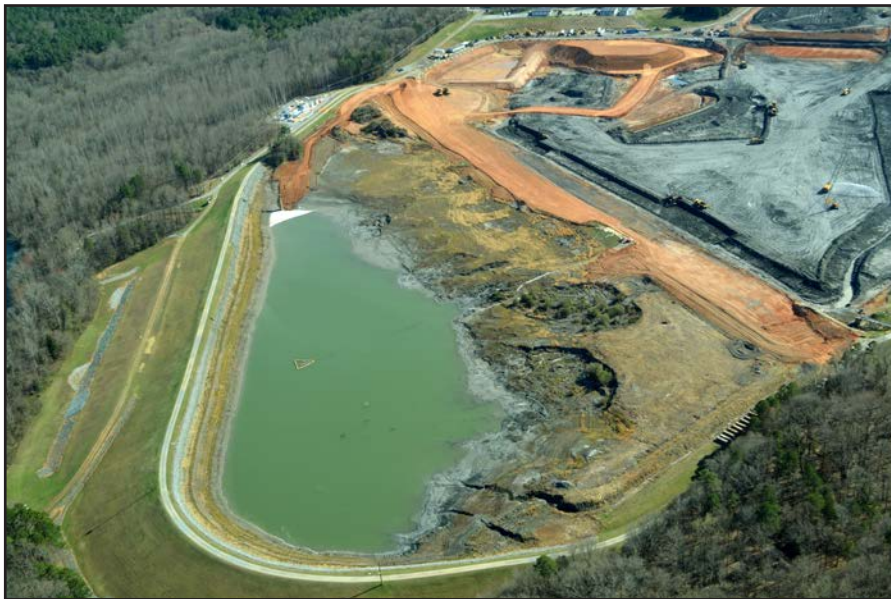
*Ash ponds at the Riverbend Plant site in North Carolina being dewatered in preparation for full ash excavation. Full dewatering is a critical first step in stopping future contamination.*

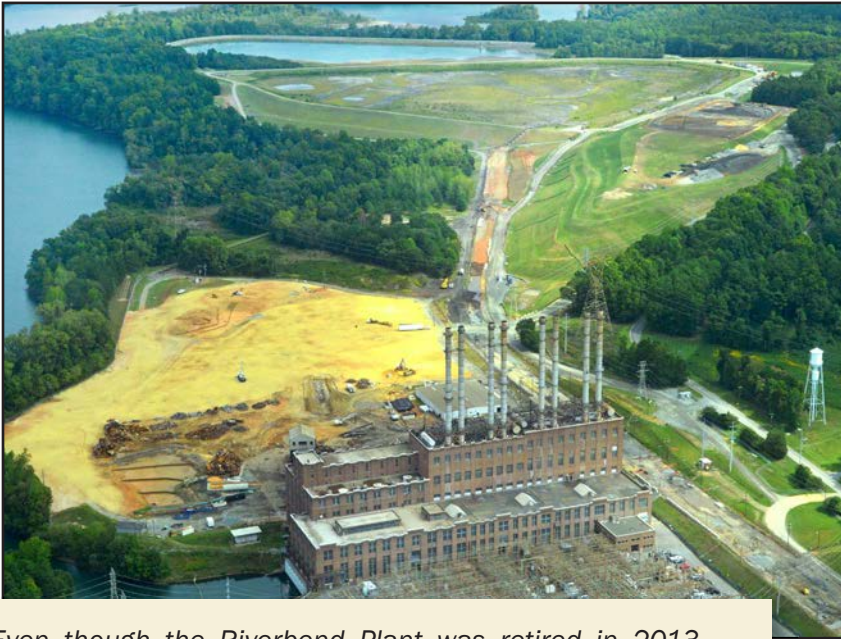
*Even though the Riverbend Plant was retired in 2013, contamination from the coal ash ponds is still an issue. To address the problem, Duke Energy built a water treatment facility to remove contaminants from the pond water. This water is then safely discharged into Mountain Lake.*
